DANISH MARITIME ACCIDENT INVESTIGATION BOARD

Marine accident report on the grounding of VICTORIA on 10 February 2017

The report is issued on 25 August 2017

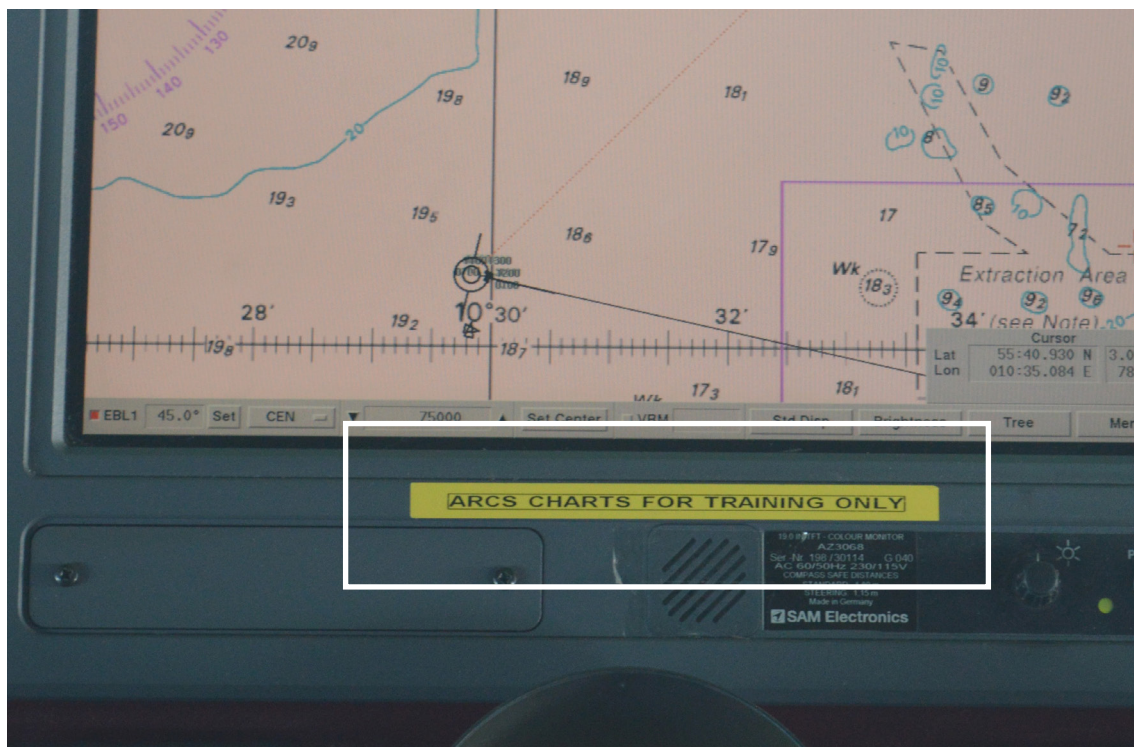
During the investigation, it was not possible to establish the intended purpose of the ECS. According to the bridge crew, it was not common to use the ECS when navigating because it was not approved and there was a sticker on the monitor highlighting that it was “ARCS CHARTS FOR TRAINING ONLY” (figure 8). It was unclear what the purpose of that training was.

The sticker informed the bridge crew that the equipment could not be used for navigation because the chart system used ARCS. During the investigation, it was not possible to establish why the chart was to be used only for training and not during the everyday navigation of the ship. VICTORIA met the mandatory requirement to carry nautical charts and nautical publications in order to plan and display the ship’s route for the intended voyage and to plot and monitor positions throughout the voyage. However, from a SOLAS regulatory standpoint, that requirement did not prevent supplementary use of an ECS with ARCS to navigate the ship. Apart from the formal intended use of the ECS, there is the question of the ECS’ actual use in the everyday navigation of the ship.

Figure 8: ECS by the conning station.
Source: DMAIB

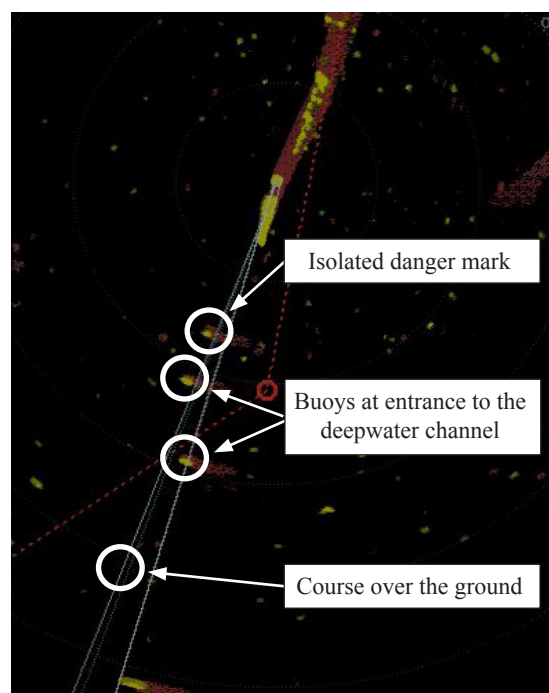
concern about the shallow waters ahead. As seen in the below extract from the ship's VDR showing the starboard radar image, the ship is heading toward the isolated danger mark and its course over ground would bring the ship aground within one minute (figure 14).

Figure 14: Extract from VICTORIA's VDR. Time: 1814.
Source: VICTORIA/DMAIB

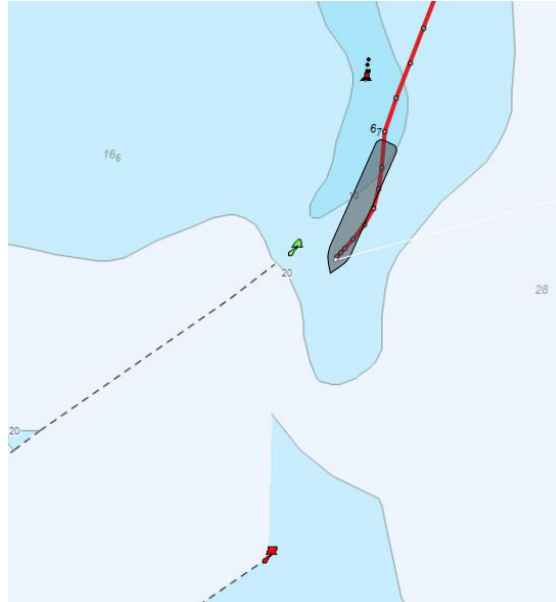
At this stage the priority was to manoeuvre the ship safely into the deepwater channel by using the red and green buoys to keep the bearing to the channel. The isolated danger mark indicating the shallow waters was not visible and was positioned in such a way that it did not direct the ship eastward of the shallow waters. When the ship was approximately 0.25 nm from the buoys, the chief officer said that it was time to turn the ship into the channel. Shortly after, at 1815, the ship started to vibrate and the master said: “What is this?”. The ship was aground and within seconds the speed was reduced from 15 knots to 7 knots (figure 15).

Figure 15: VICTORIA aground at 1816 (not to scale).
Source: © Made Smart Group BV 2016, C-Map data © Jeppesen AS 2016

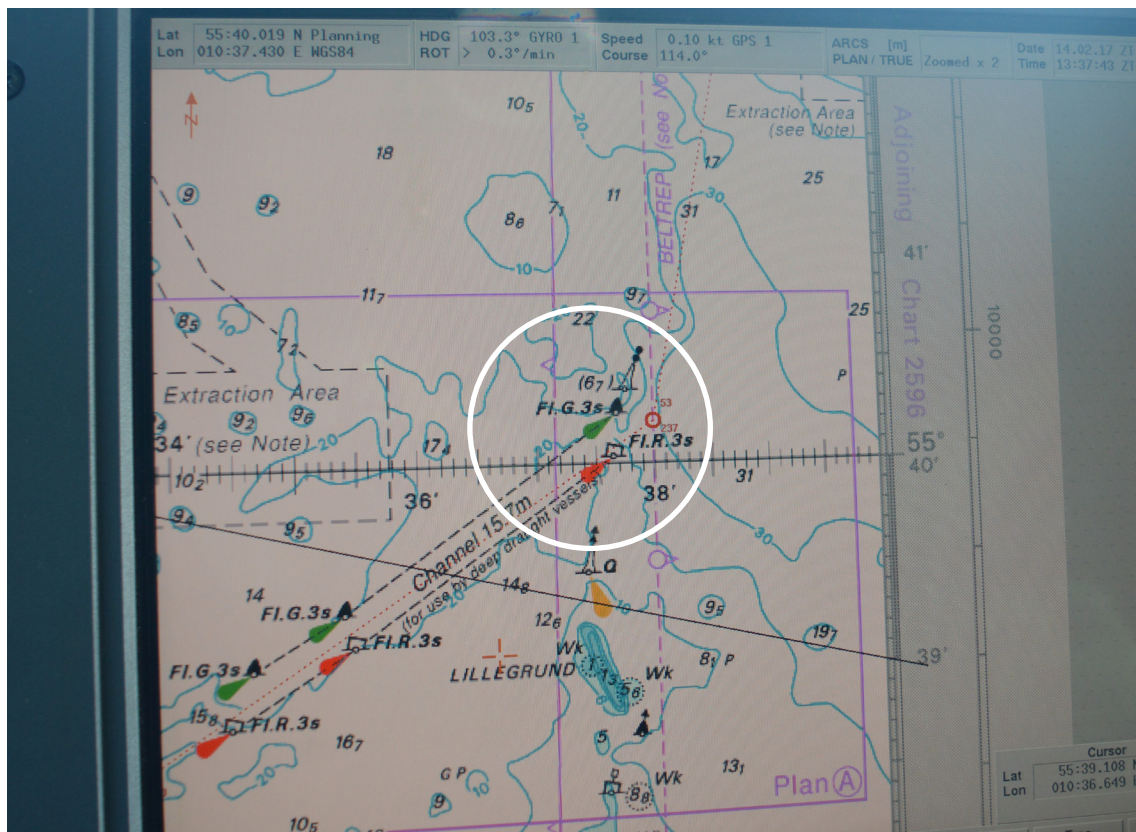
Figure 15 does not represent the ECS chart which was available to the bridge crew at the time of the accident. Figure 16 below shows a photo from the ECS screen on VICTORIA, which shows how the chart would have presented itself to the bridge crew. The scale of the chart shown is what was available to the master and chief officer shortly before the grounding when they were in the process of positioning the ship for the turn into the deepwater channel. From that photo it becomes clear how the bridge crew was led to assume that the isolated danger mark would direct them clear of the shallow water area. In a situation where focus was on turning the ship, the ECS did not offer them sufficient warning that they were heading for shallow waters.

Figure 16: Photo of ECS screen showing the deepwater channel at Lillegrund.
Source: VICTORIA/DMAIB

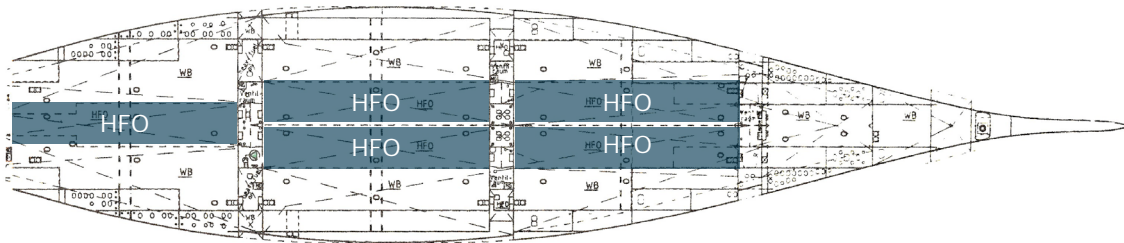
Shortly after the grounding, the crew was concerned about the possibility of heavy fuel oil (HFO) leaking from the ship's bottom tanks because the gauges showed an increased pressure in the tanks which indicated that the hull had been breached. VICTORIA carried approximately 720 t of fuel oil in five bottom tanks (figure 17), which could potentially leak into the sea. The day after the grounding, an underwater inspection of VICTORIA's hull was

Figure 17: Location of bottom fuel tanks.
Source: DMAIB

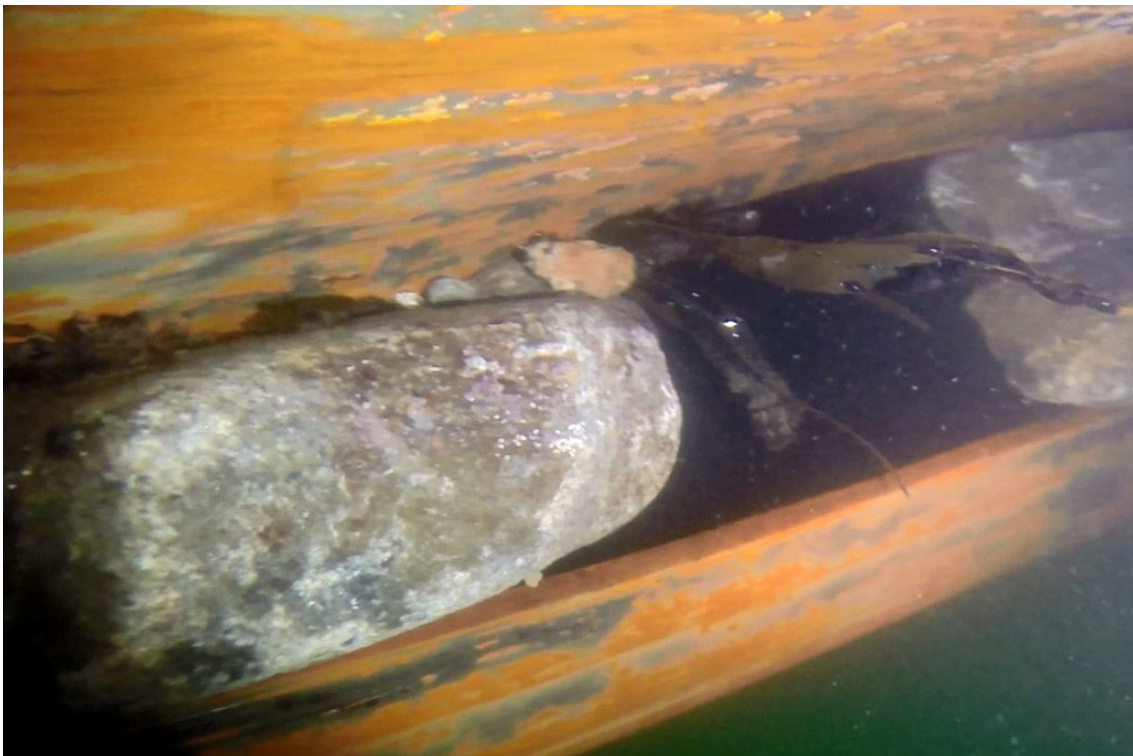
made. The divers found that the ship's bottom plating had deformation of the plating and indentations. Furthermore, the bottom of the hull had been breached in several places along the starboard side damaging several fuel oil tanks. Stones and gravel from the seabed were found in the cracks in the bottom plating (figure 18). The fuel oil in the tanks had solidified when it came into contact with the cold sea water and the water pressure kept the oil within the tanks (figure 18 and 19).

Figure 18: Damage to the starboard side hull.
Source: Peter Doehle Schifffahrts-KG/DMAIB

The bottom plating on the starboard side was found partly cracked/torn off, severely buckled and deformed to a varying extent. Indentations of the plating between the frames showed deflections of up to about 400 mm in some areas. The most severe damage was noticed in way of the fuel oil double bottom tanks no. 3/4 and no. 5 port, where the bottom plating was torn off and stones/gravel were found in-between the demolished plating as well as inside the tanks. About 40 t of oil-contaminated rocks/gravel was removed from the tanks and disposed. The longitudinal bulkhead between fuel oil double bottom tanks no. 3/4 port and starboard, as well as between no. 5 port and starboard, were found damaged. Five propeller blades were bent to various extents as a result of colliding with rocks/stones.

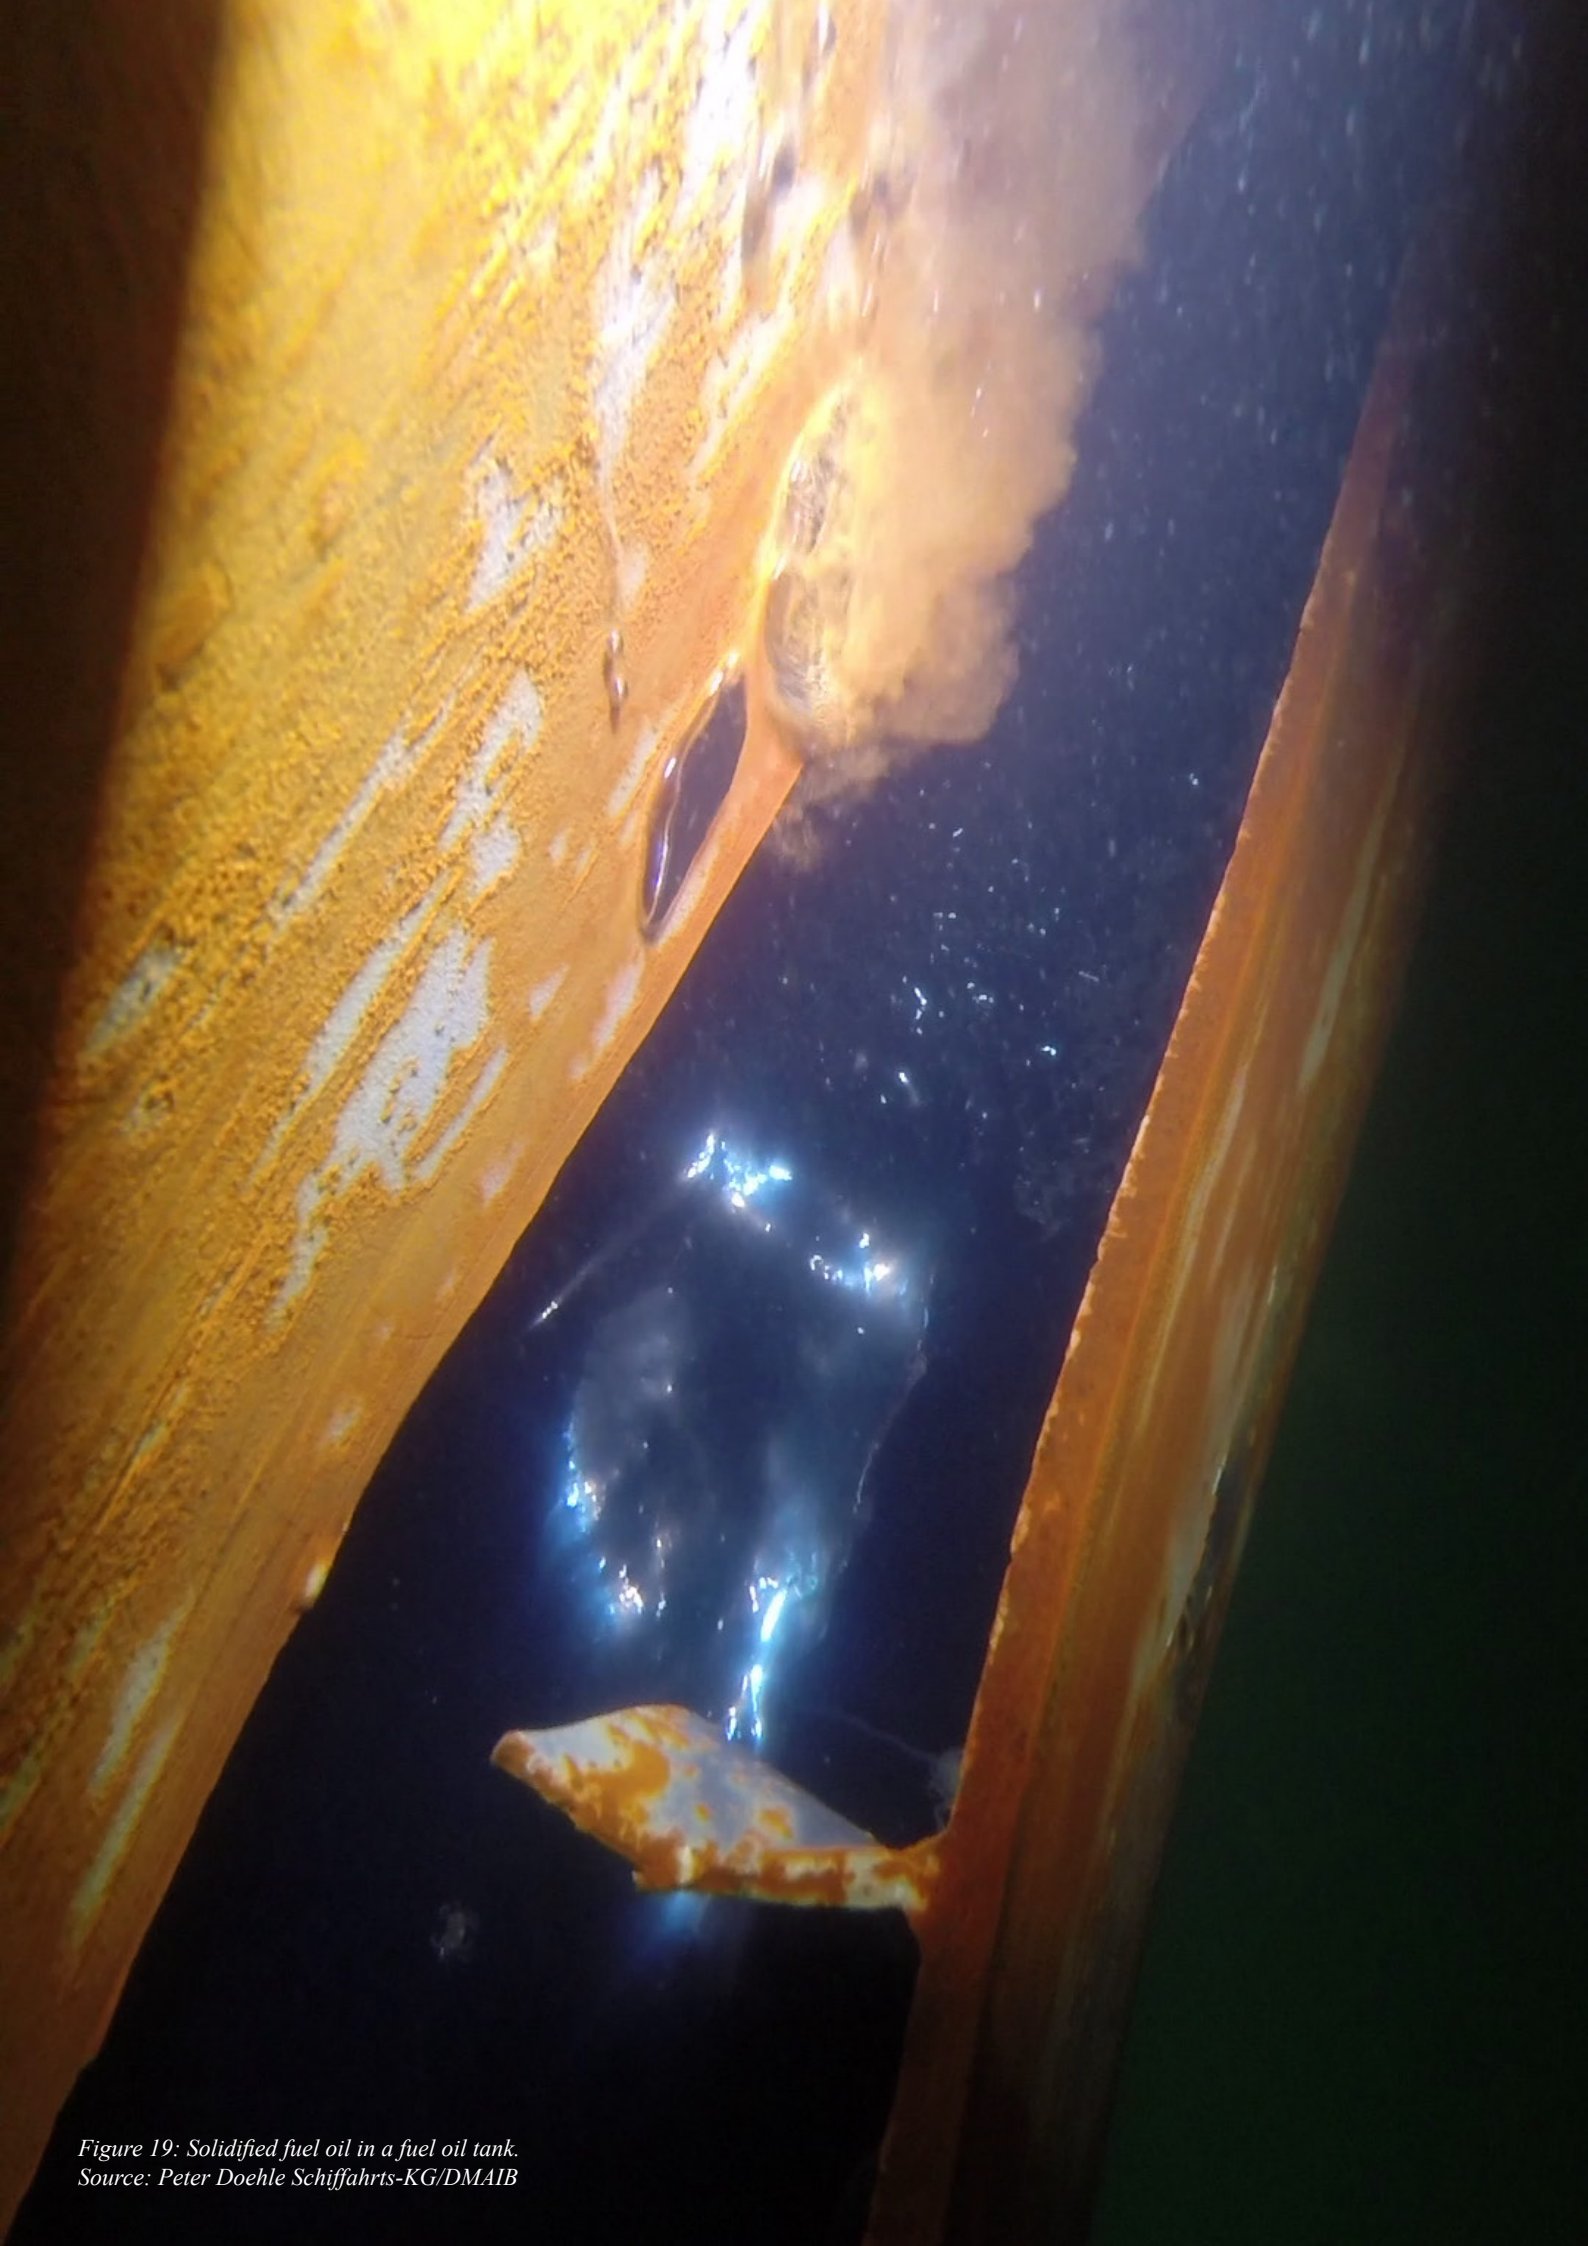
*Figure 19: Solidified fuel oil in a fuel oil tank.
Source: Peter Doehle Schifffahrts-KG/DMAIB*

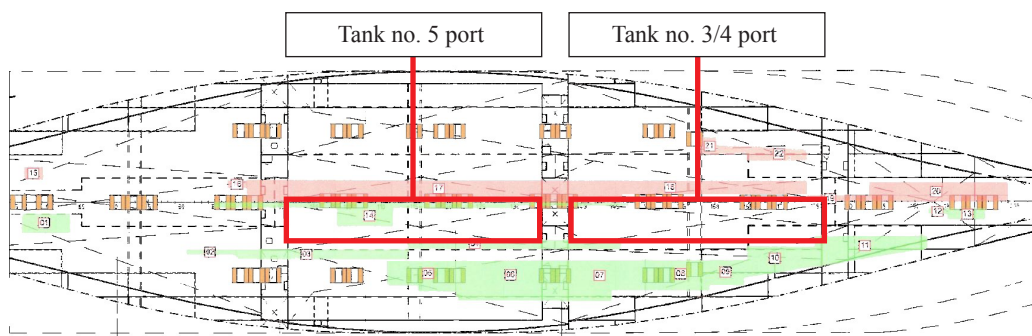
Figure 20: Extent of damage to VICTORIA's bottom plating.
Source: Peter Doehle Schiffsahrts-KG/DMAIB

Later, when VICTORIA was in dry dock, the extent of the damage became clear. Above in figure 20 the extent of the damage is illustrated in red and green colour.

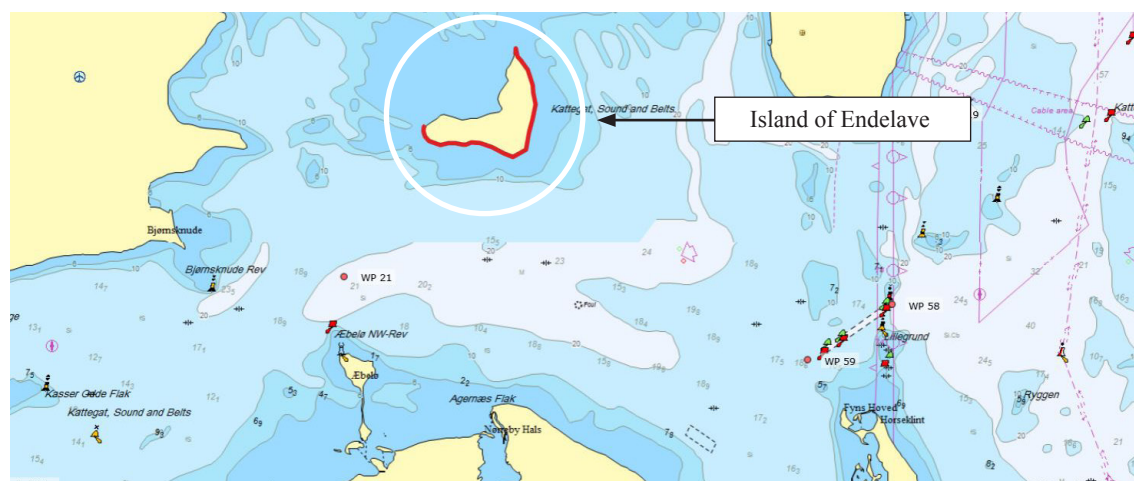
Data collected from the municipalities in the area east of the position of the grounding suggest that mainly the island of Endelave was affected by the oil spill. Approximately 13 km of the island's coastline (figure 24) was affected as oil washed ashore on multiple occasions during a period of 14 days. During the clean-up, approximately 60 t of eelgrass and 11 t of rocks were removed from the coast. In other municipalities, only minor quantities of oil were observed and cleaned up. It has not been possible for the DMAIB to establish how large a quantity of oil was spilled.

Figure 21: The island of Endelave. The extent of the pollution is marked with red.
Source: © Made Smart Group BV 2016, C-Map data © Jeppesen AS 2016
