Danish Maritime Accident
Investigation Board

MARINE ACCIDENT REPORT

PARIDA
Fire on 7 October 2014

This marine accident report is issued on 2 June 2015

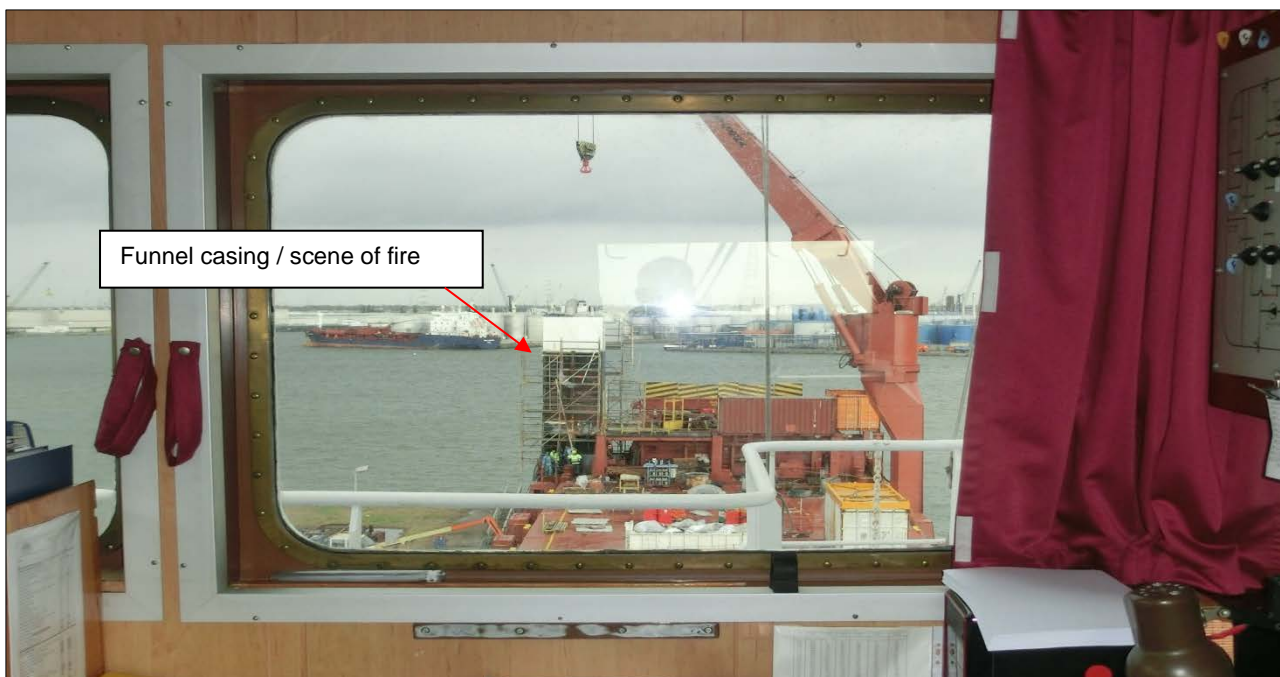
Soon after, the chief officer observed, through the rear windows of the bridge, flames from the ship's funnel casing (figure 4). At the same time, the supercargo entered the bridge informing the master about a similar observation of fire in the funnel. Immediately after, the chief engineer also entered the bridge to discuss some administrative matters with the master. The chief engineer immediately understood the seriousness of the situation and hurried down to the engine control room.

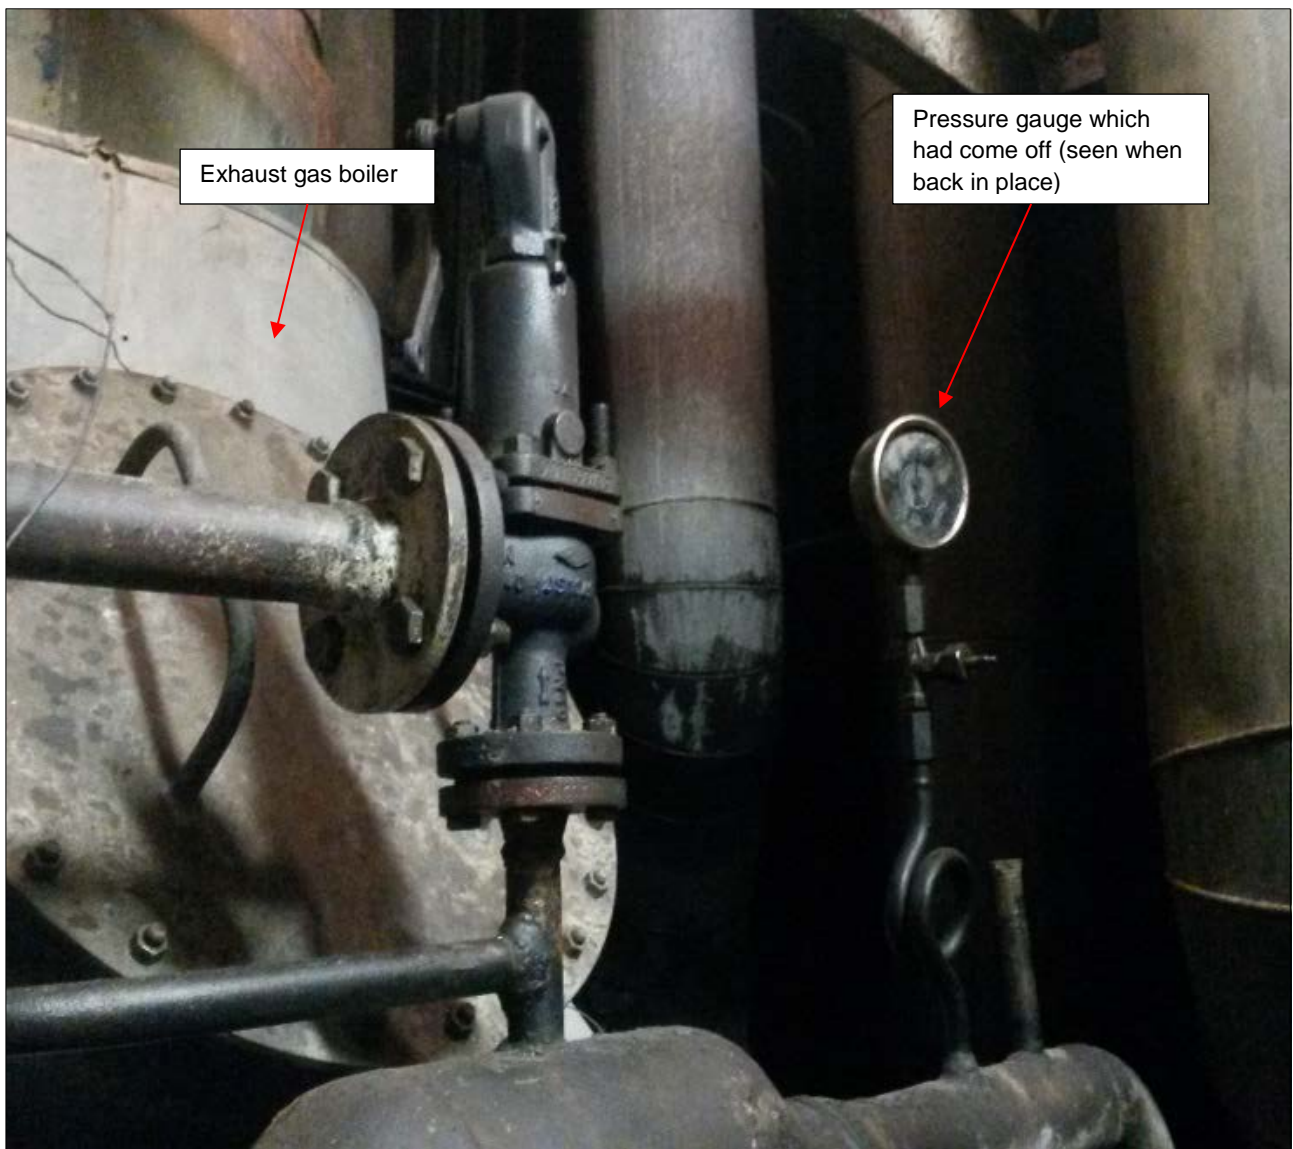
Figure 7: Unscrewed pressure gauge and exhaust gas boiler
Source: Harren & Partner/DMAIB

The pressure gauge appeared to have unscrewed from the pipe end where it had been fitted. It was assumed by the 2nd engineer that the fire had originated from the flow of pressurized thermal heat-oil from the open pipe end, ignited by the surfaces of the main engine funnel. The chief officer reported the findings to the master, on the bridge, and a crew member was put on permanent watch at the scene of the fire and fire hoses were kept readily available.

The pressure gauge came loose and fell off, possibly due to the motions in the aft ship induced by slamming. The oil sprayed into the area at a pressure equivalent to the system pressure of approx. 8 bars. The oil was then ignited by an ignition source present in the area.

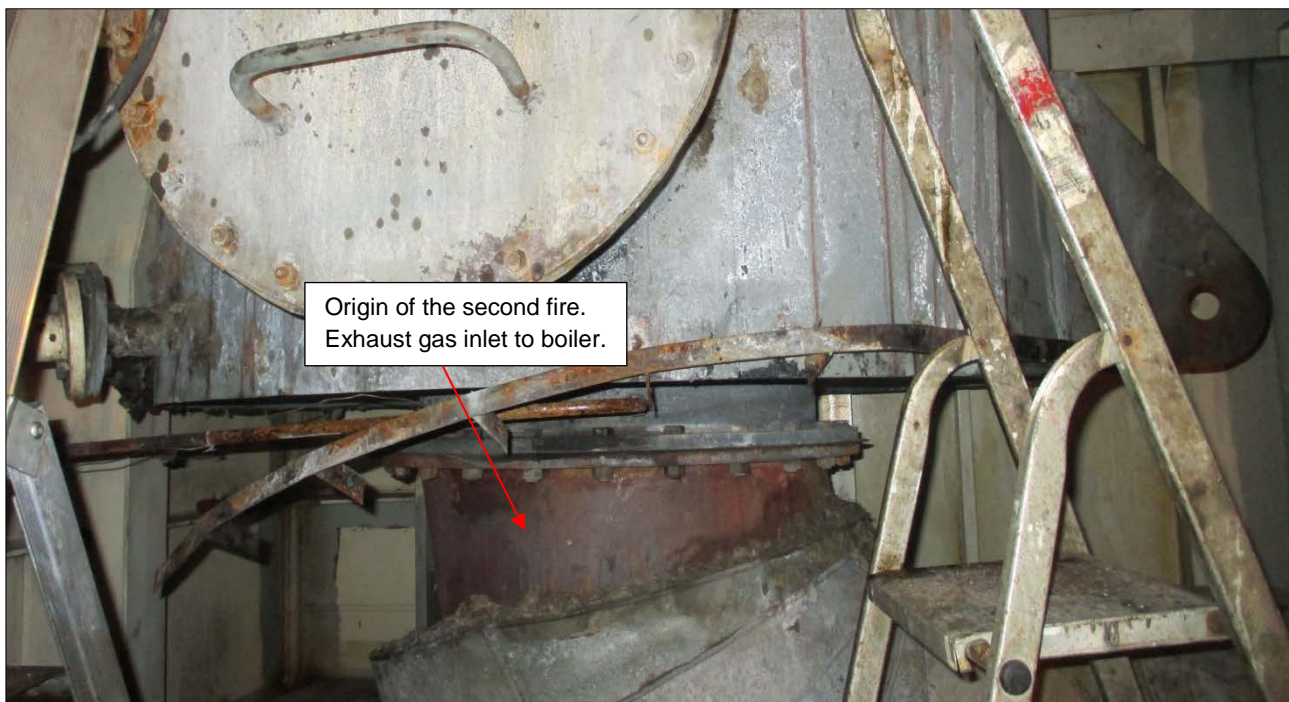
Figure 14: Bottom of exhaust gas boiler with removed insulation
Source: Harren & Partner/DMAIB

The crew members initiated stripping of some oil soaked insulation from the exhaust pipe and exhaust gas boiler at the bottom of this (figure 14). A thorough cleaning of the area was also carried out. Upon completion the crew members prepared to resume the voyage towards Antwerp. A permanent watch was stationed inside the funnel casing.

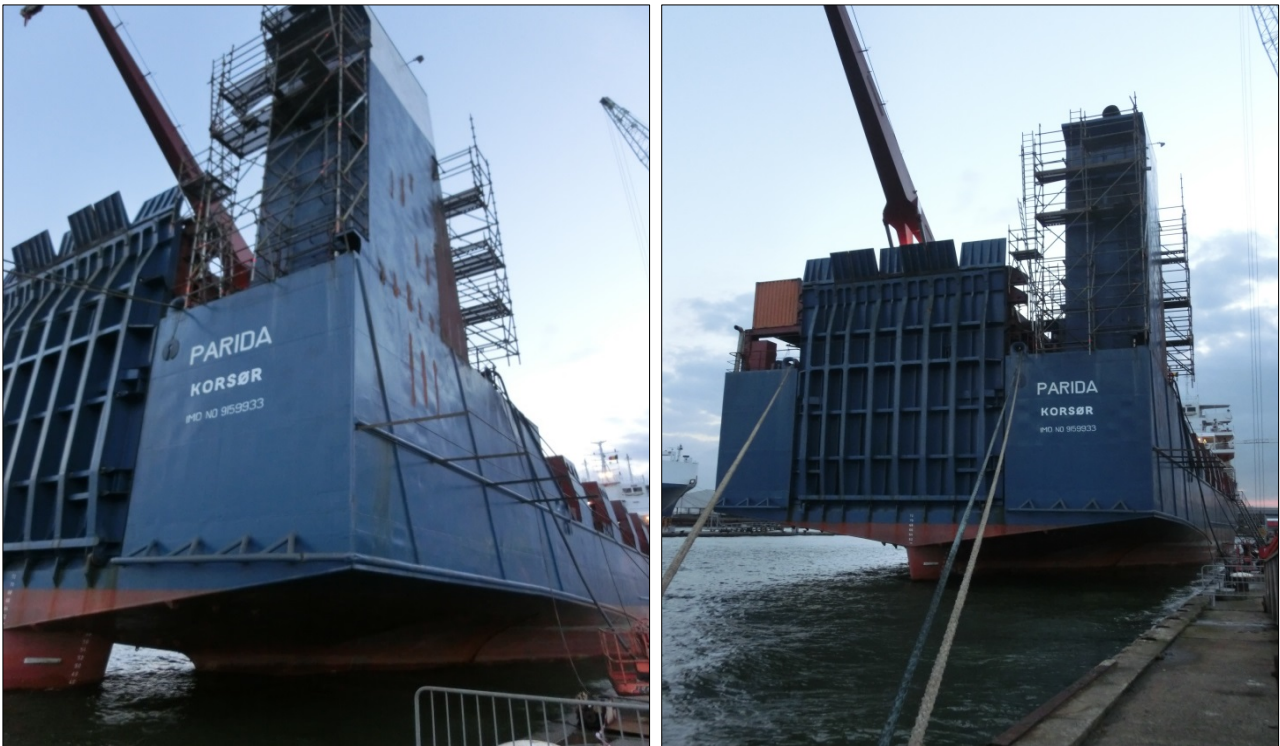
PARIDA left Scrabster on the day of the accident with a draft of 4.6 m aft and 4.2 m forward. The design draft was 6.93 m. The relatively low draught on the day of the accident is likely to have made the aft part of the ship particularly susceptible to slamming from the sea during the prevailing weather conditions as the bottom of the aft ship would have been exposed in a way similar to what can be seen in figure 16. In the picture, the ship is shown alongside with approximately the same draught that it had on the day of the accident.

Figure 16: Aft end of PARIDA susceptible to slamming
Source: DMAIB

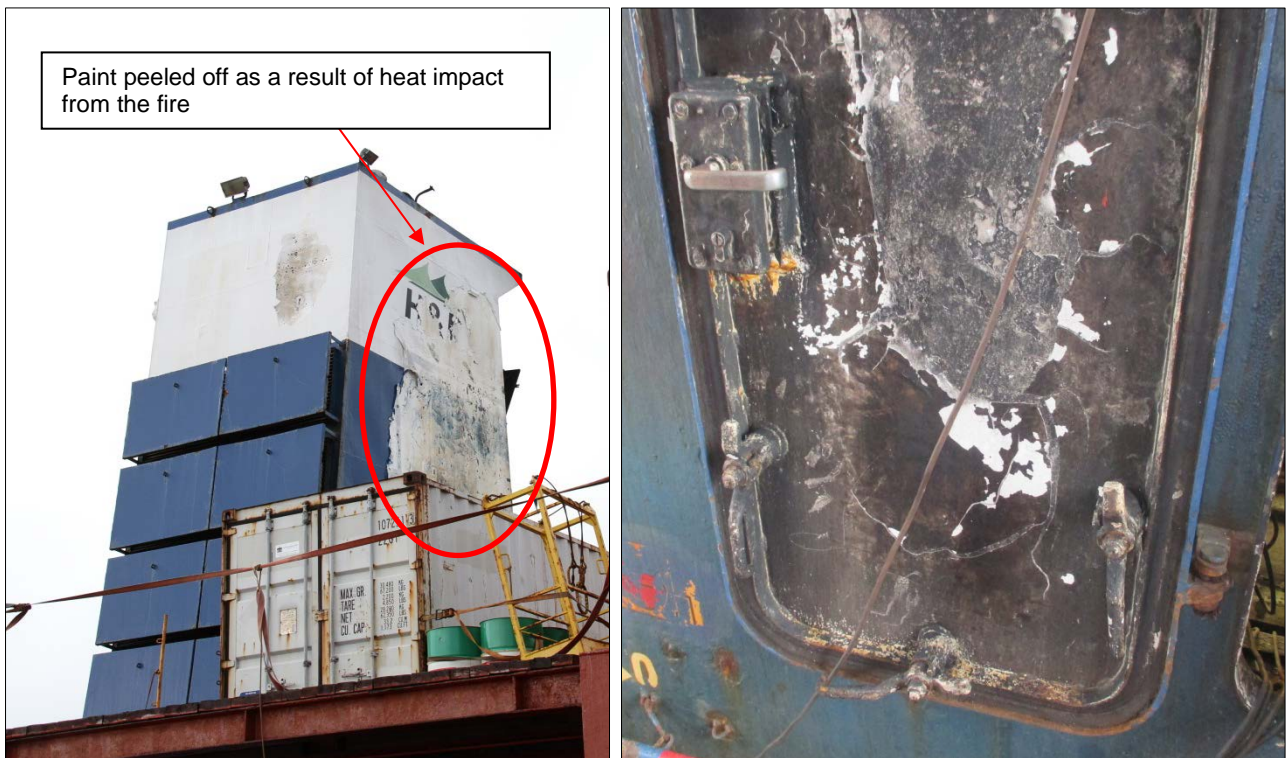
The exterior of the funnel casing was clearly heat affected in such a way that the paint had peeled off in some places. The sealing on the entrance door to the casing had partly melted (figure 18).

Figure 18: Exterior of funnel casing and entrance door to casing
Source: Harren & Partner/DMAIB

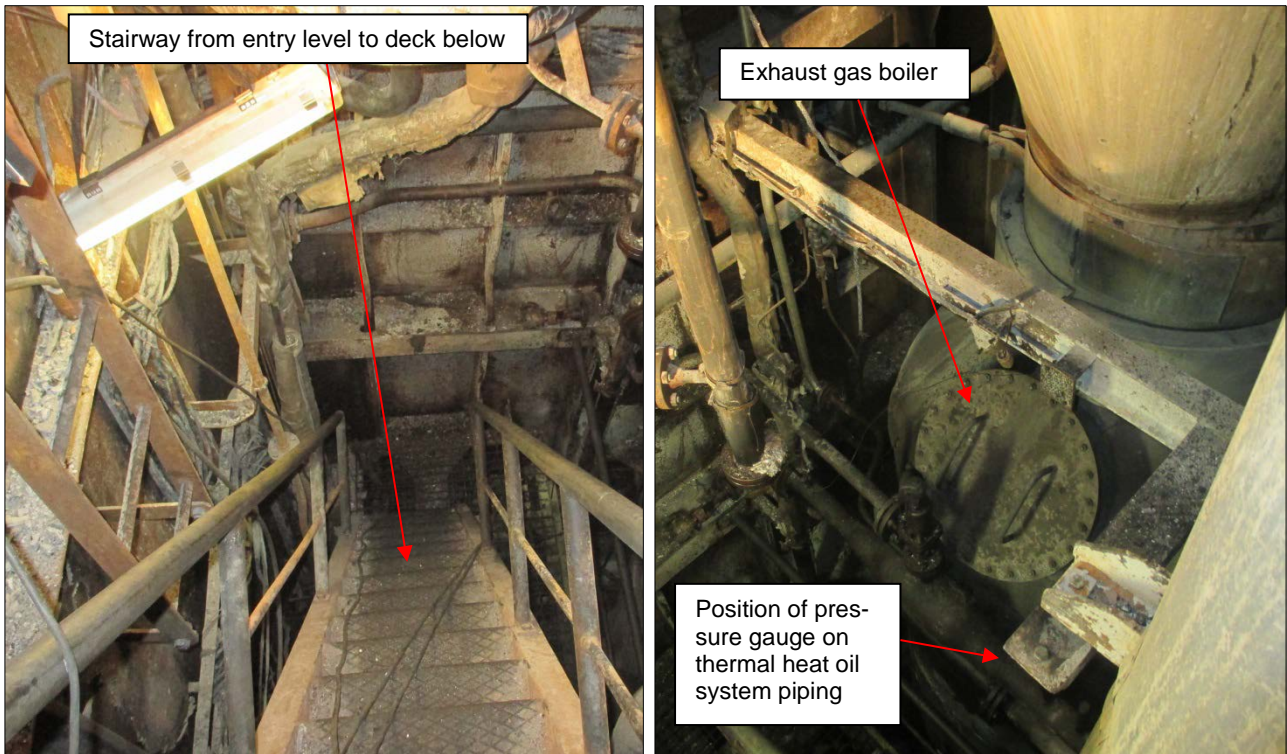
The inside of the casing was substantially damaged by the fire. Particularly on the forward and starboard side bulkheads, the paint had been burned and soot covered the bulkheads. Insulation on electrical wires was burned in several places. The electrical sensors and actuators on the thermal heat-oil components had been destroyed. The insulation material used on the piping was damaged by the fire in several places. The exhaust gas boiler appeared to have suffered only minor damage (figures 19 and 20).

Figure 19: Left: View ahead when entering the casing after the fire. Right: View to the right side (exhaust gas boiler)
Source: Harren & Partner/DMAIB

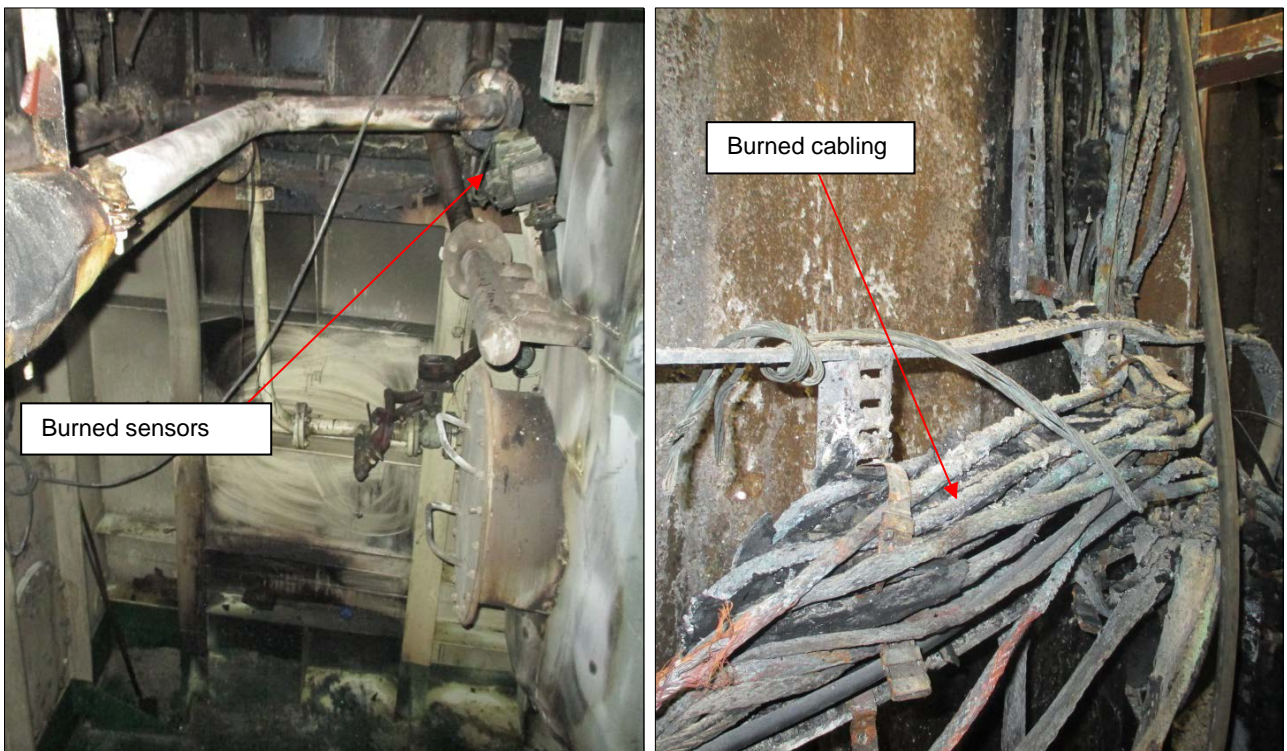
Figure 20: Burned sensors and wiring for the thermal heat oil system in the casing area
Source: Harren & Partner/DMAIB

During the fire several of the thermal heat-oil system components that were located in the funnel casing area, were severely damaged. The damaged sensor cabling initiated the alarm sequence in the control system when the connection to the panel and the power to the sensors were lost. This resulted in the shutdown of the thermal heat-oil circulation pump and the triggering of the flow safety alarm.

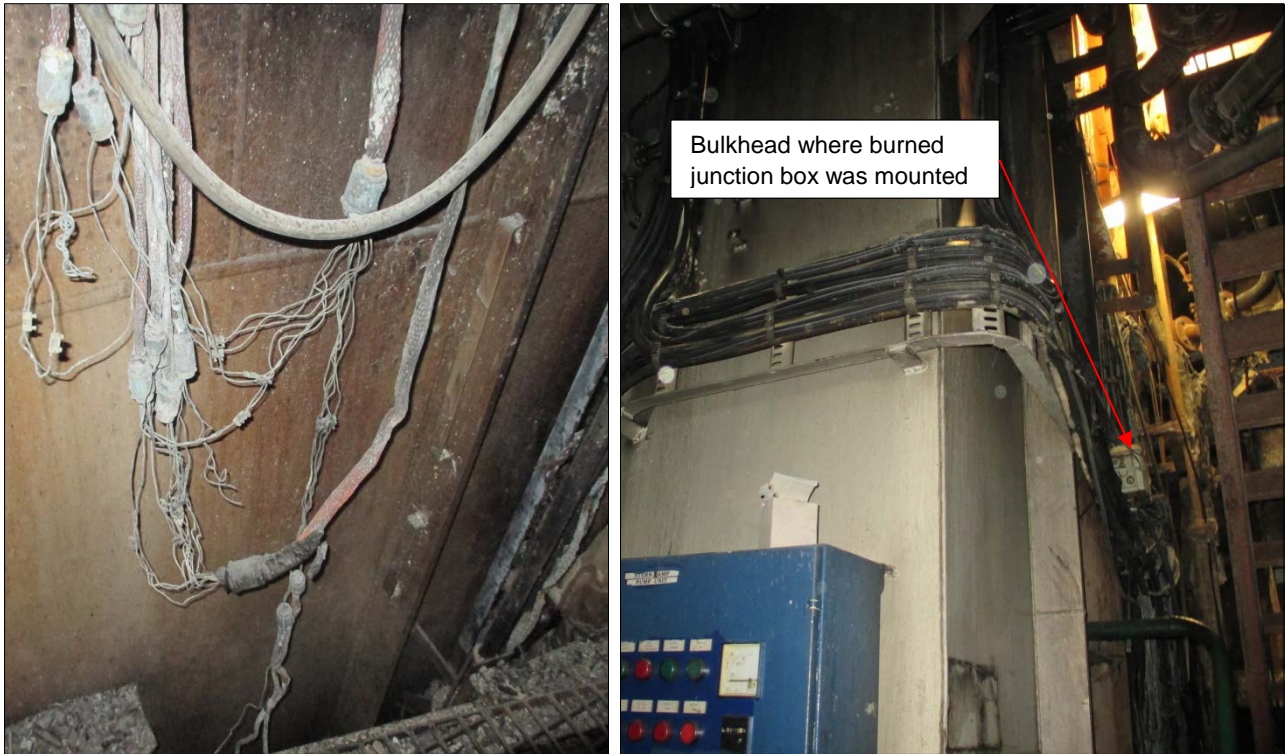
Under the stairs the electrical junction box, mounted on the forward bulkhead, had been completely destroyed by the fire. Only remains of the wiring and the mounting brackets remained (figure 21).

Figure 20: Left: Remains of wires from junction box. Right: Bulkhead left of stairway where junction box was mounted, seen from half level down.

In the casing area, several electrical installations were found to be burned, including the junction box where the electrical wiring to the 24-volt thermal heat-oil sensor system was connected. Based on the glands visible on the electrical cables after the fire, the junction box appears to have been encapsulated at a level equivalent to IP 44 which protected the junction box against water ingress and particles.

Therefore, it is unlikely that the ignition source is the combined effect of oil inside the burned electrical junction box. However, it cannot be dismissed that two simultaneous events combined to create the fire; one being the pressure gauge unscrewing from the fitting on the pipe, and the other being electrical arcing inside, and subsequent burning of either the particular junction box, a fluorescent light fixture or another electrical installation in the casing area.
