DANISH MARITIME ACCIDENT INVESTIGATION BOARD

Marine accident report on the grounding of VICTORIA on 10 February 2017

The report is issued on 25 August 2017

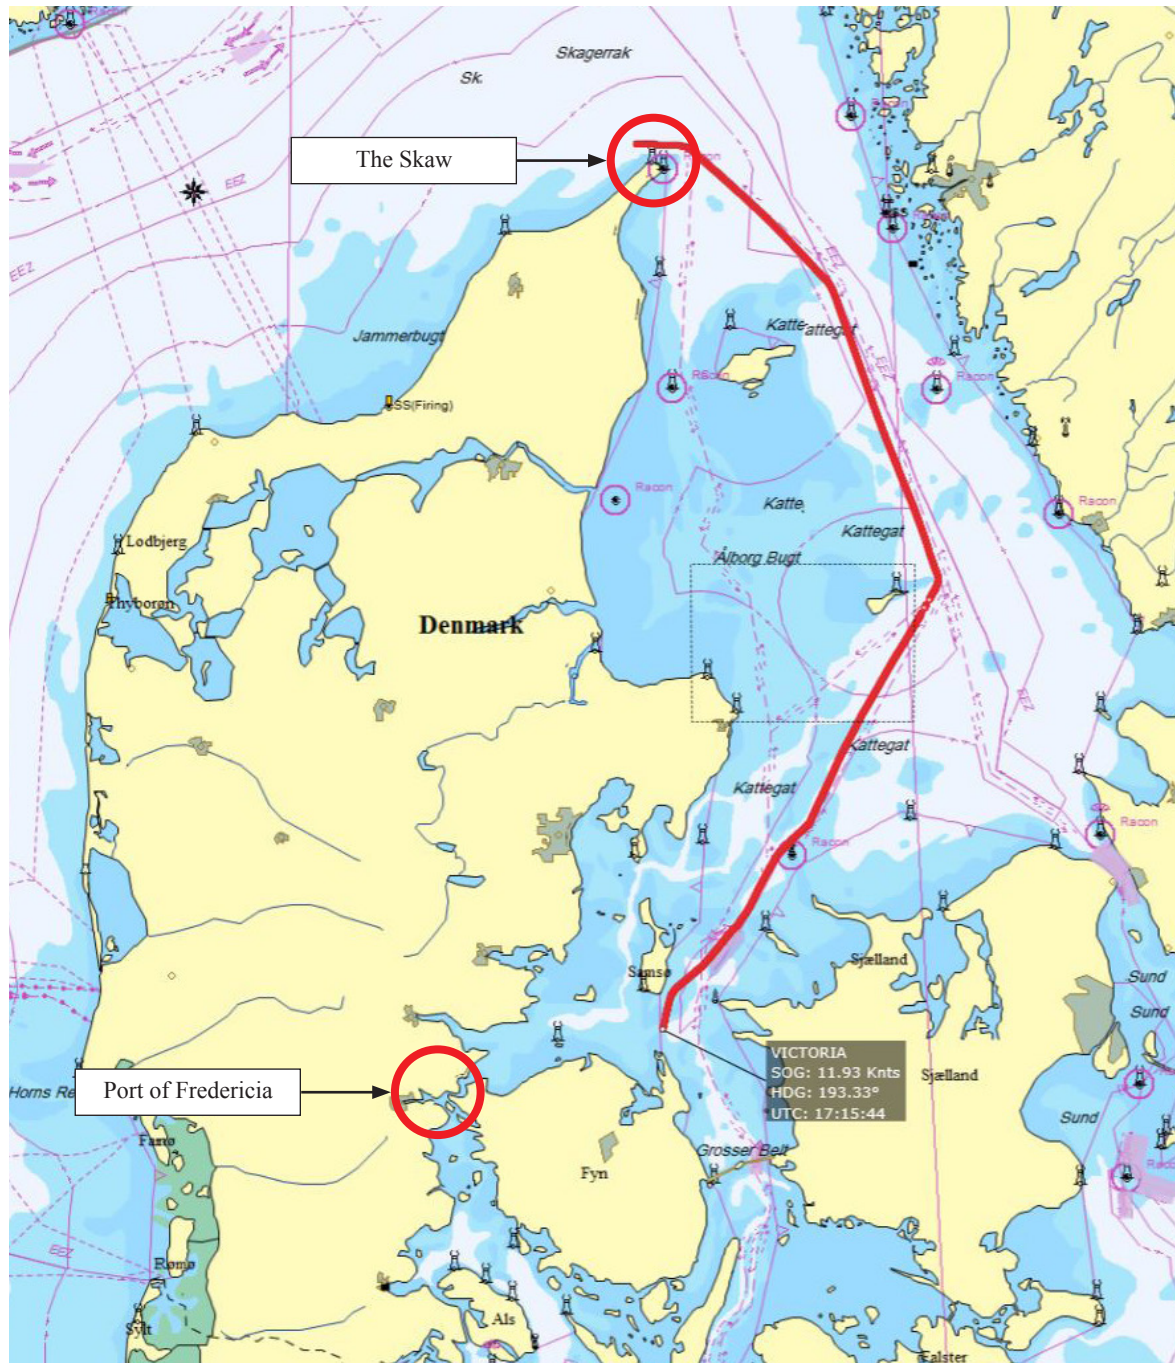
In figure 1 below VICTORIA's AIS track is shown from the Skaw until moments before the grounding. The planned route took the ship via the North Sea, along the west coast of Jutland, passing the Skaw before entering Route T in Kattegat.

Figure 1: Route from the Skaw until immediately before the grounding.
Source: © Made Smart Group BV 2016, C-Map data © Jeppesen AS 2016

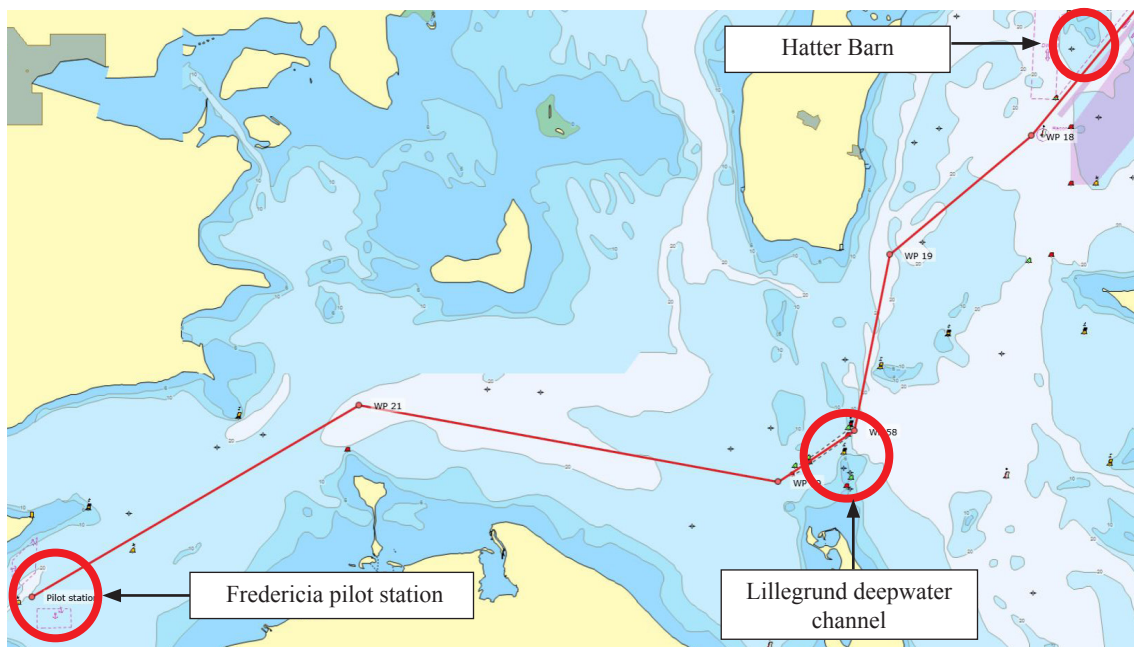
When approaching the Skaw at approximately 0900 on 10 February, the master came to the bridge to assist the officer of the watch because the waters could be congested and because navigation was restricted in some areas in Route T due to shallow waters. During the morning and early afternoon, the passage southbound along Route T went as planned. There was little traffic and the visibility was good. On the bridge there was a relaxed atmosphere; the deck officers and the master small talked about personal and work related topics. During the morning and afternoon, several crewmembers came to the bridge to drink coffee and small talk. This was not unusual because the bridge was commonly used as a meeting place for the deck officers. At approximately 1530, the chief officer arrived on the bridge to relieve the 2nd officer at 1600. At 1647, VICTORIA entered the Great Belt VTS area and the VTS operator called VICTORIA. The chief officer informed the VTS operator that VICTORIA would not embark a pilot in the Great Belt and that the intention was to approach Fredericia via Hatter Barn and the deepwater channel at Lillegrund (figure 2).

Figure 2: Route from Hatter Barn to Fredericia pilot station.

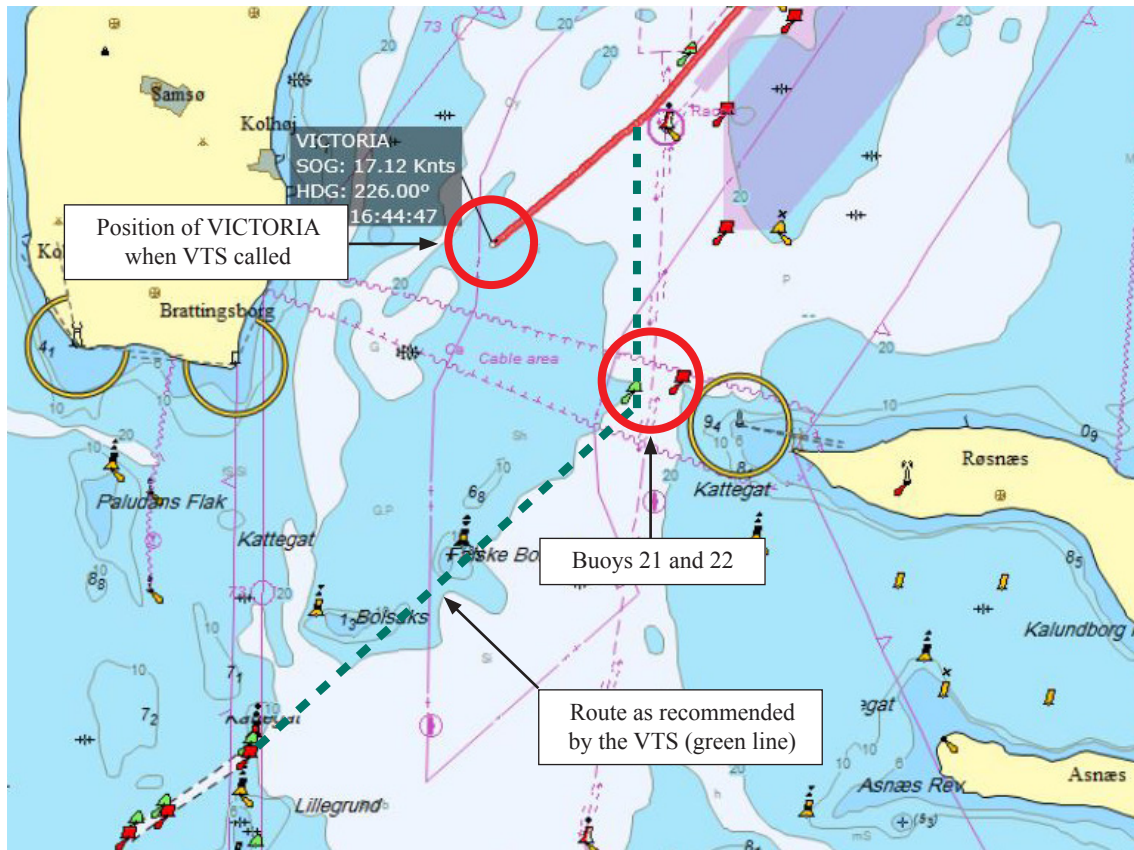
At 1745, the Great Belt VTS called VICTORIA to confirm that VICTORIA intended to enter the deepwater channel at Lillegrund as reported earlier. The chief officer confirmed the intention and that the plan was to alter course towards Lillegrund within 10 minutes. The VTS operator stated that VICTORIA had chosen an "untraditional" approach and warned the chief officer about shallow waters in the area. The operator communicated to the chief officer that ships normally approached Lillegrund via buoys 21 and 22 south of Hatter Barn (see green dotted line in figure 3, next page).

Figure 3: Traditional route towards Lillegrund as proposed by the VTS.
Source: © Made Smart Group BV 2016, C-Map data © Jeppesen AS 2016

The VTS operator concluded that VICTORIA had proceeded too far for altering the course towards buoys 21 and 22 and told the chief officer that he would keep an eye on the position of VICTORIA. The chief officer replied that he would inform the master about the changing of the route.

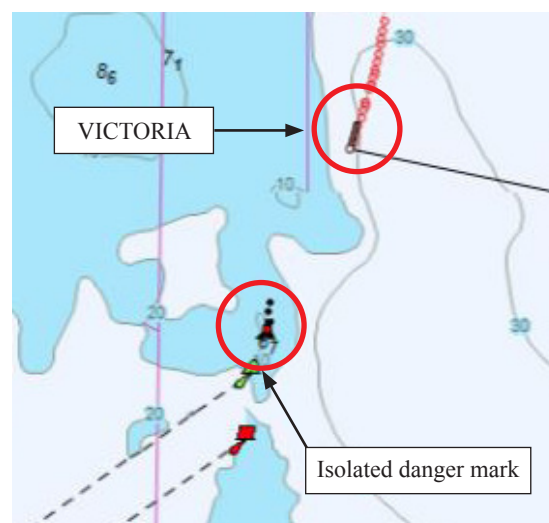
The sun was about to set (sundown was at approximately 1815) and the ship approached the deepwater channel at Lillegrund (figure 4). The master took the command assisted by the AB at the helm. The bridge crew visually identified the green buoy which they used to position the ship so that they could make a soft turn into the deepwater channel. From the chart the shallow water north of the entrance was noted, but the isolated danger mark close to the channel entrance was not visually detected.

Figure 4: VICTORIA approaching the deepwater channel at Lillegrund at 1813 LT (not to scale).
Source: © Made Smart Group BV 2016, C-Map data © Jeppesen AS 2016

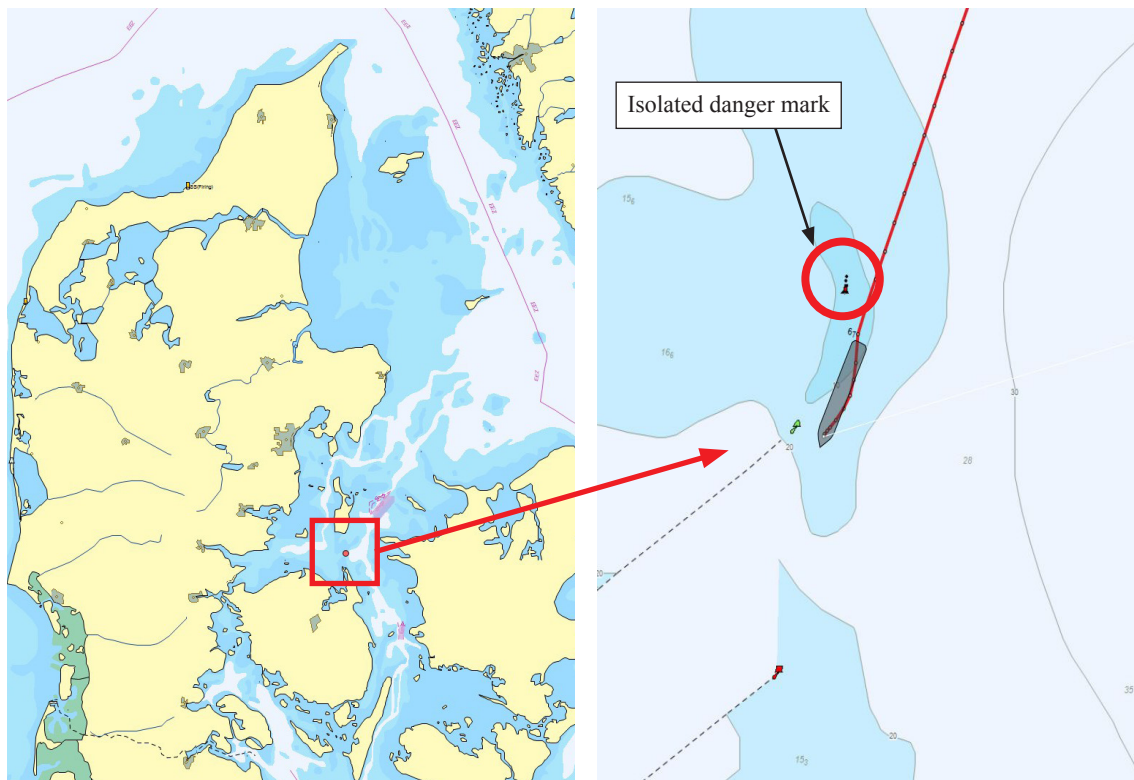
Figure 5: VICTORIA aground 1815 (not to scale)
Source: © Made Smart Group BV 2016, C-Map data © Jeppesen AS 2016

On the bridge alarms started to sound, the phone rang and the officers discussed what had happened. The engineer rang from the engine room and reported that the fuel tank level indicators showed that the bottom tanks were full, which indicated that the hull had been breached and the water pressure pushed the fuel oil level up in the tank. The master asked the chief officer to call the VTS to report the grounding and to tell one of the junior officers to go aft to see if oil could be observed. Meanwhile, the 2nd officer arrived on the bridge and went to the chart table to identify the position of the grounding. The chief officer and the 2nd officer discussed where the grounding had occurred and quickly identified the shallow water marked with the isolated danger mark (figure 5). They thereby knew where the ship went aground.

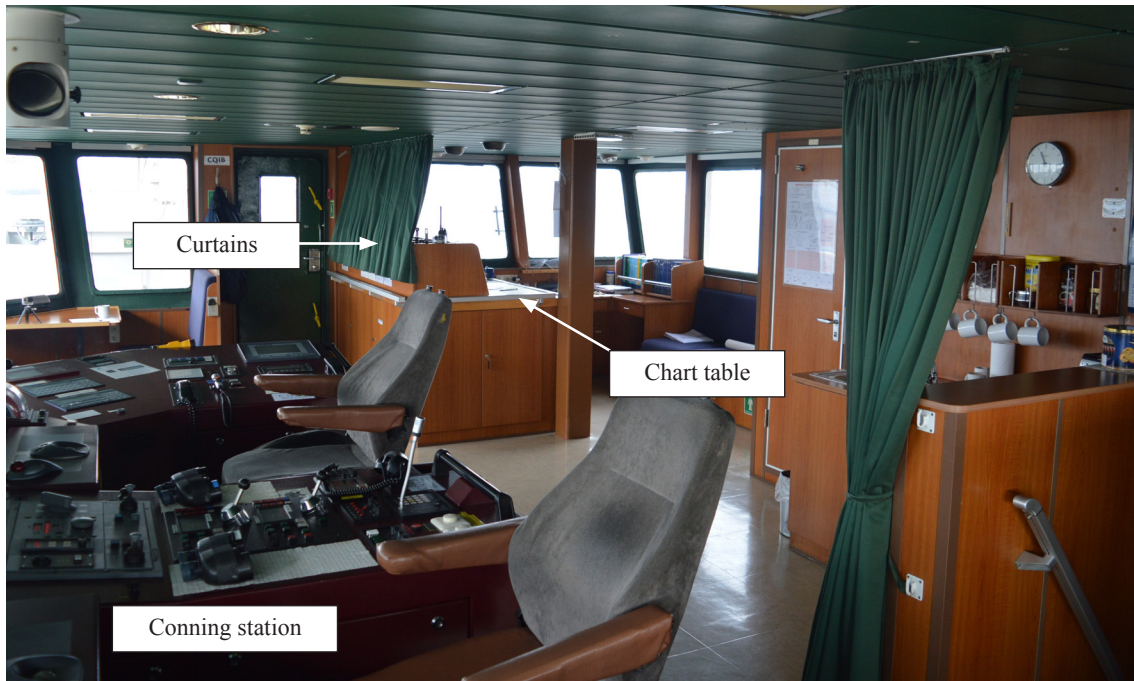
relation to the course line could be established. During the watch, the officer therefore regularly had to move between the chart table and the conning station to fix the position of the ship and to observe the movements of other ships in the area. In the photo below, the conning station and the chart table are seen from the port side (figure 6).

Figure 6: Conning station and chart table seen from port side.
Source: DMAIB

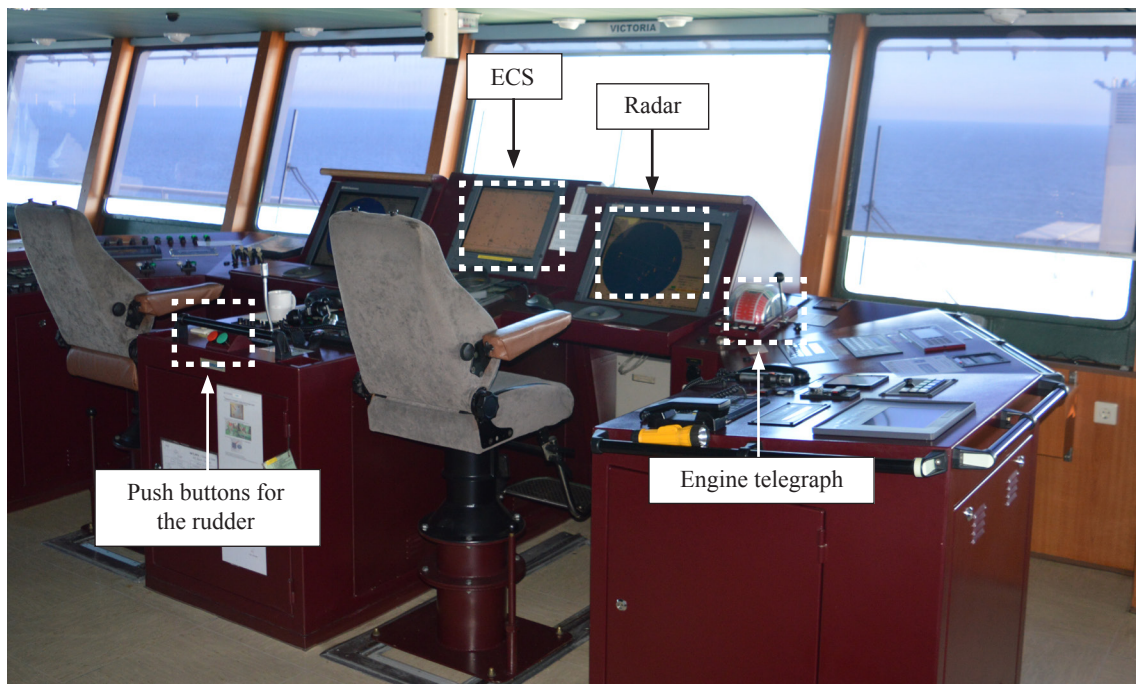
Figure 7: Conning station on VICTORIA.
Source: DMAIB

In figure 7 on the previous page, the conning station is shown from the aft starboard side. During the voyage the officer of the watch typically sat in the right-hand chair. From there he/she had access to the engine controls, the radar and an ECS into which the route was loaded. The helmsman stood at the centre using the push buttons to operate the rudder. When the master was in command, he/she would sit in the chair on the right and the navigational officer would sit in the left chair.

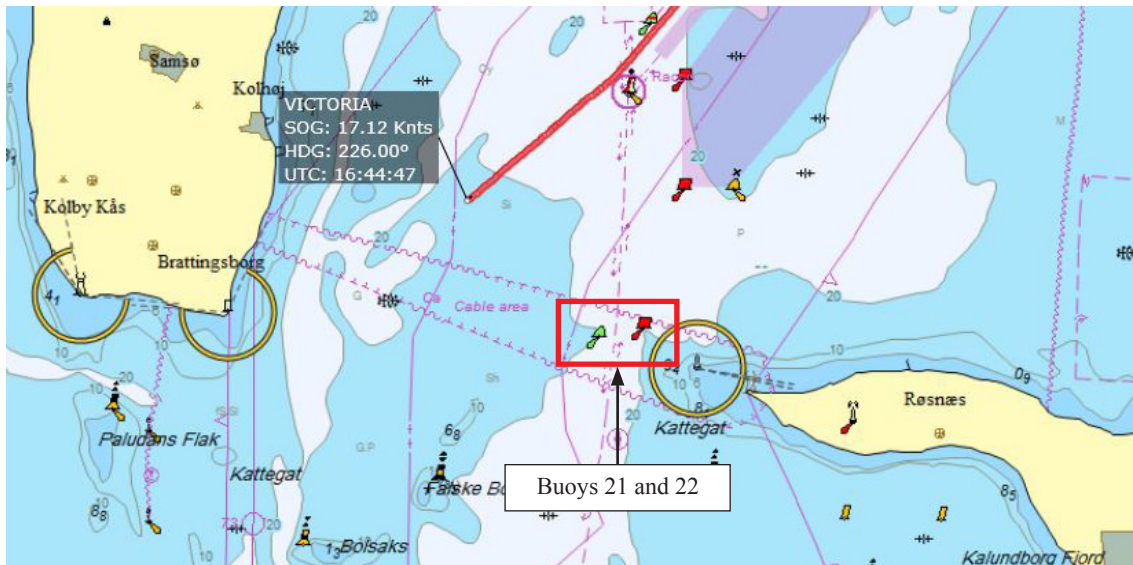
reached the VTS area of the Great Belt, the passage plan was brought into question by the VTS operator at 1744 (approximately 20 minutes before the grounding). The VTS operator had previously been informed by the watchkeeping officer on VICTORIA that the intention was to approach Fredericia via the deepwater channel by Lillegrund, but the position of VICTORIA indicated that the ship was not approaching the deepwater channel via buoys 21 and 22, which the VTS operator perceived to be the traditional route (figure 9). To understand the intentions of VICTORIA the operator called the ship a second time.

Figure 9: VICTORIA's position when the VTS called the second time.

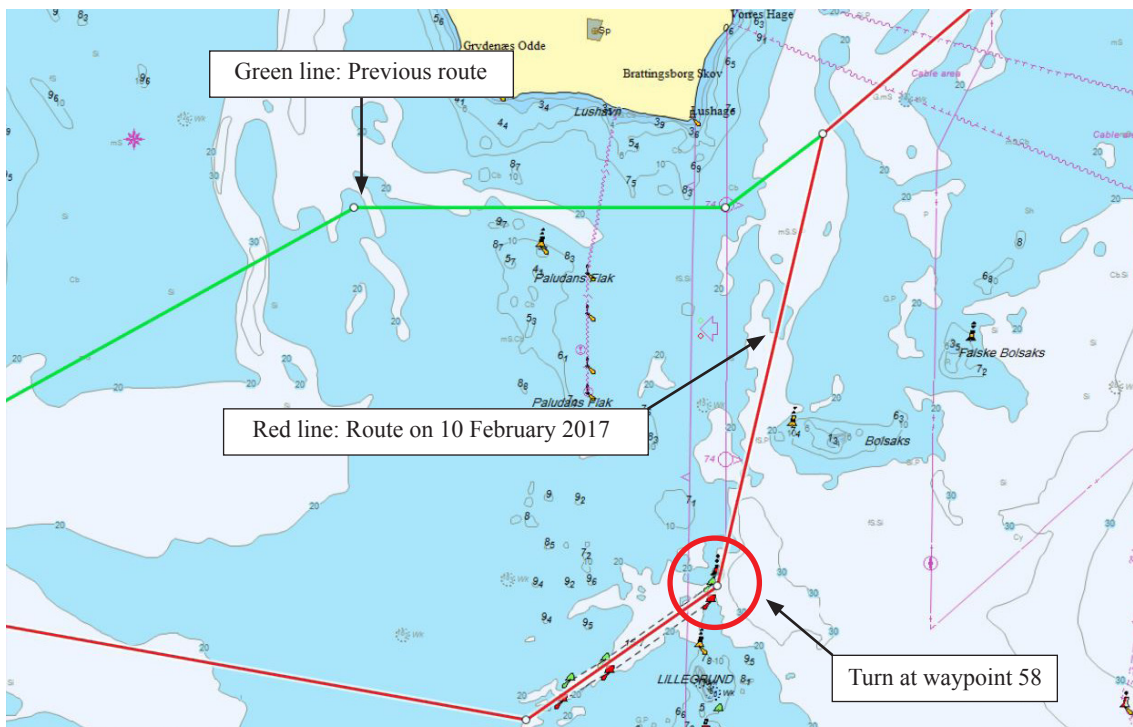
Figure 10: VICTORIA's two planned routes to Fredericia.

Different passage plans between the Danish ports had been made because the schedule frequently changed. Two different routes were used to Fredericia depending on the draught of the ship. The layout of the two routes can be seen in figure 10 on the previous page.

The route on 10 February was chosen because the draught would exceed the accepted under keel clearance in the previous route. Therefore, the navigational officer made a new passage plan based on the way points from the previous passage plan. The charts did not indicate that there was a recommended route to the deepwater route and therefore the shortest route was made from the latest waypoint. The new route meant that, in order to enter the deepwater channel, the ship had to change its course from 192° to 237° at waypoint 58 (figure 11). It proved to be difficult to make that course change at a speed of 16 knots, in the dark and at a westerly current of approximately 1.0-1.4 knots.

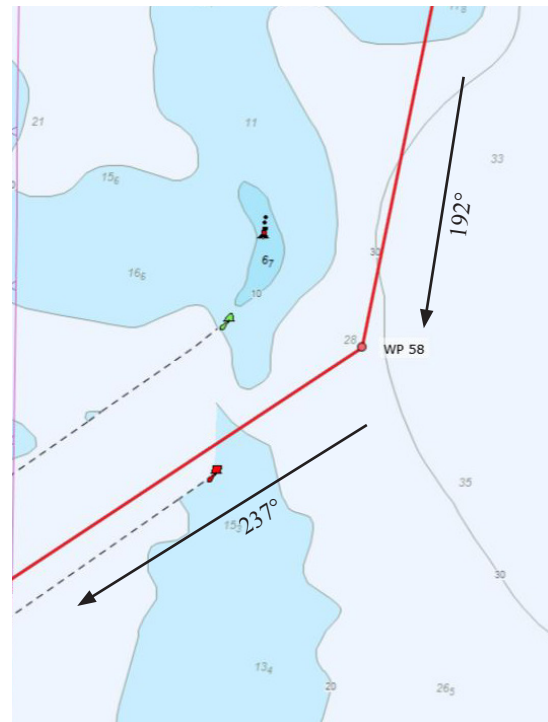
Figure 11: Planned route in the deepwater channel
Source: © Made Smart Group BV 2016, C-Map data © Jeppesen AS 2016/DMAIB

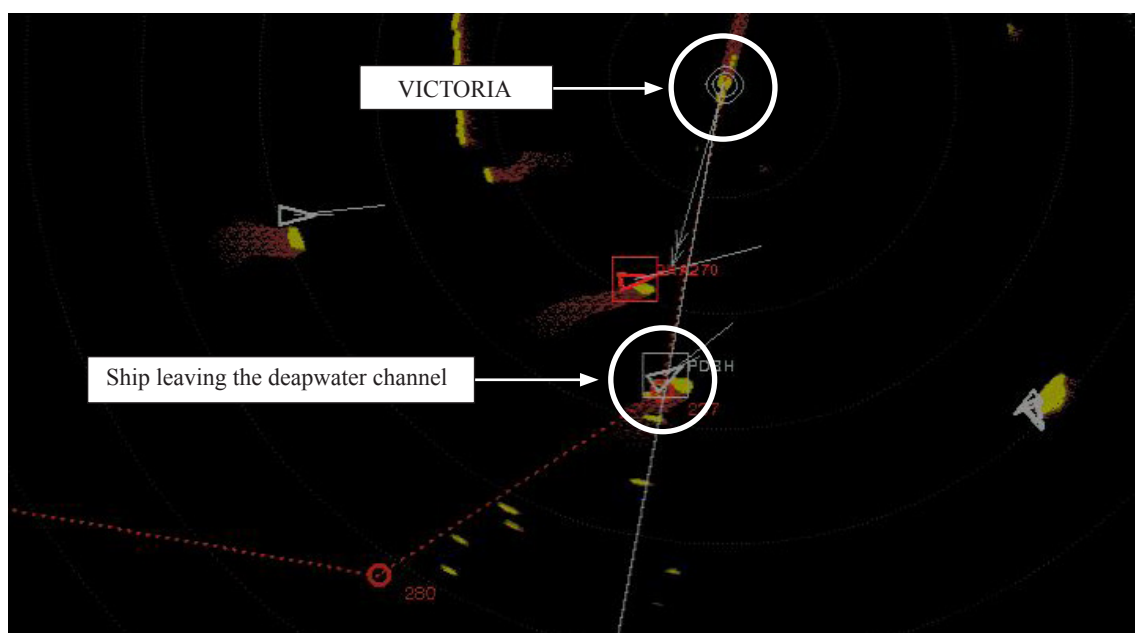
As the ship approached the deepwater channel, the master and the chief officer were sitting at the conning station and the helmsman was standing at the helm. The chief officer was in command and was therefore sitting in the chair to the right. During the approach, a ship was leaving the deepwater channel which is seen in the extract below from the starboard side radar (figure 12).

Figure 12: Ship leaving deepwater channel. Extract from VICTORIA's VDR. Time: 1805.
Source: VICTORIA/DMAIB

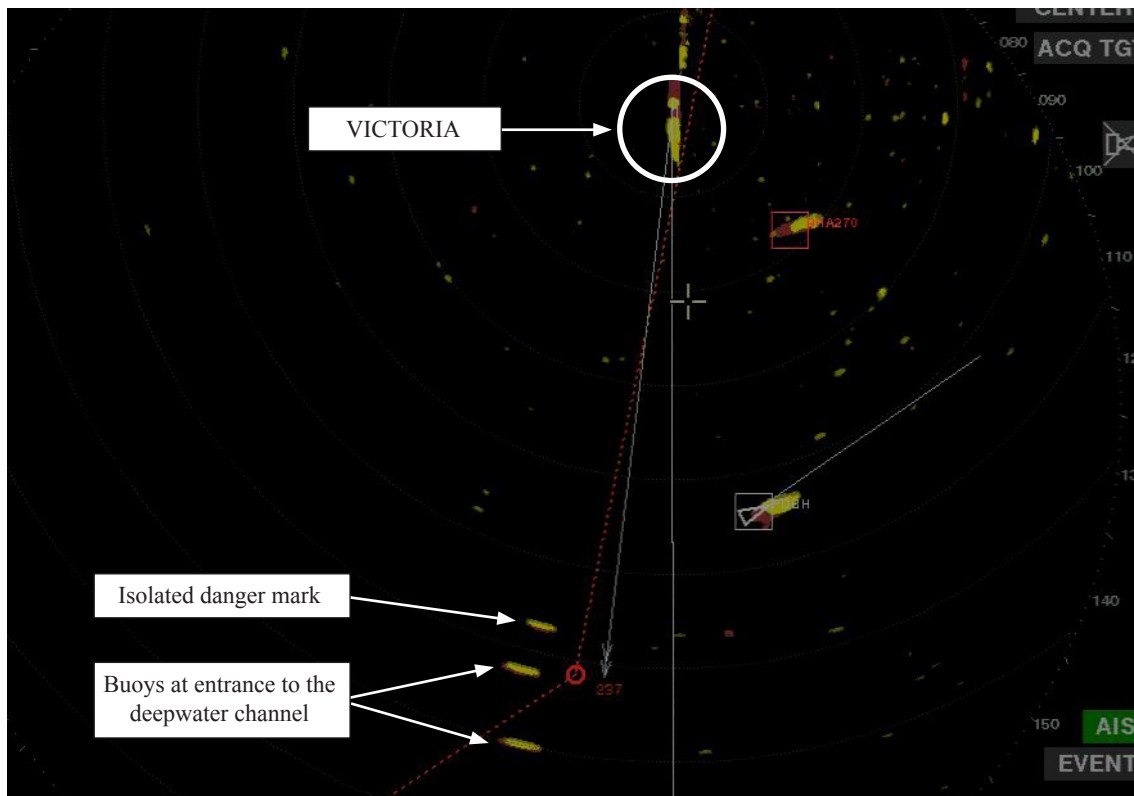
Figure 13: Extract from VICTORIA's VDR. Time: 1810.
Source: VICTORIA/DMAIB

At this time, the chief officer and the master had a short discussion about the angle to the buoys at the entrance to the deepwater route. The chief officer was worried that the angle of approach would make it difficult to execute a turn into the channel, which was only approximately 0.2 nm wide with the presence of a shallow water area north of the buoys. They agreed to follow the stern of the ship leaving the channel, thereby turning to port to allow a larger turning circle. Meanwhile, the current and wind started to affect the ship in such a way that the difference between the steered course and the course over ground was 4-7 degrees. At a distance of approximately 1.5 nm to the green buoy, VICTORIA was turned to port, but at this point the ship was already west of the course line and the alteration of the course did not significantly bring the ship eastward, but kept it on the previous course over the ground (figure 13).
