Danish Maritime Accident
Investigation Board

MARINE ACCIDENT REPORT

PARIDA
Fire on 7 October 2014

This marine accident report is issued on 2 June 2015

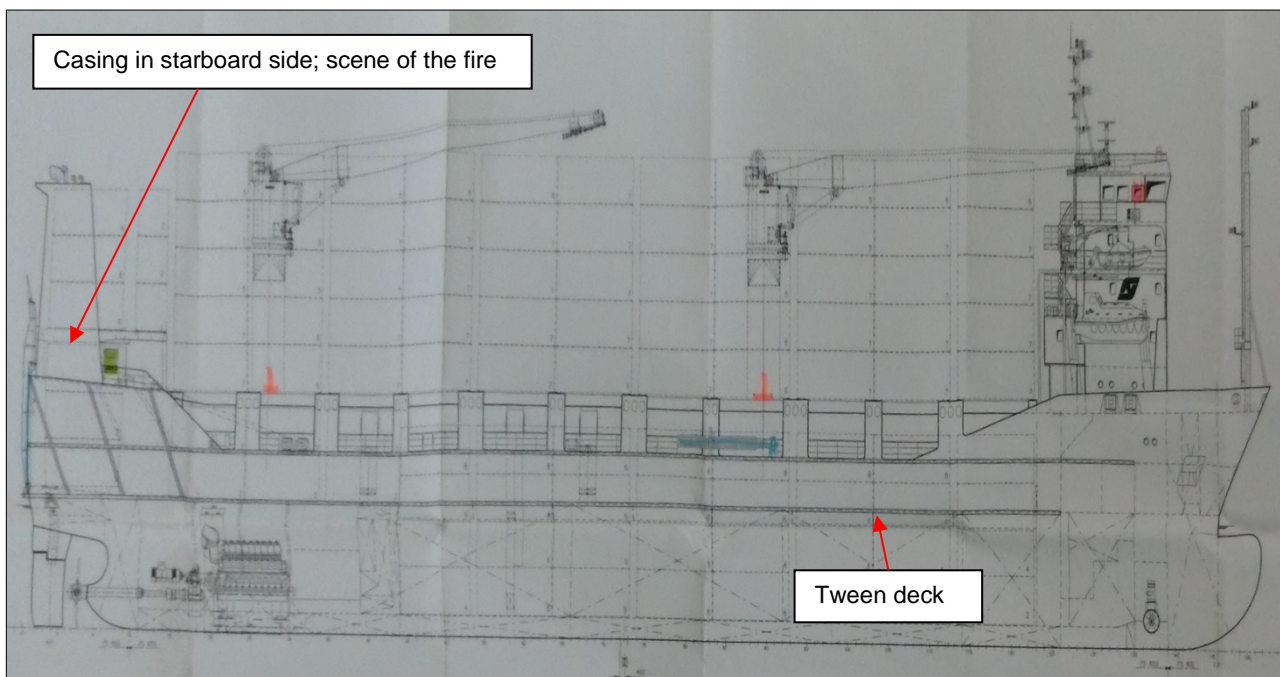
Figure 5: General arrangement of PARIDA
Source: Harren & Partner/DMAIB

The master sounded the general alarm. He remained on the bridge while the chief officer proceeded towards the muster station on the starboard side of the second accommodation deck. All additional crew members mustered at the muster station, except the chief engineer who mustered in the engine control room and the 2nd engineer who was on duty in the engine room. The chief officer briefly informed the crew members about the emergency situation. He instructed the members of the firefighting team to proceed to the firefighting equipment store on the aft ship and prepare for firefighting. To avoid exposure to the adverse weather, the firefighters went to the aft deck via the sheltered tween deck (figure 5).

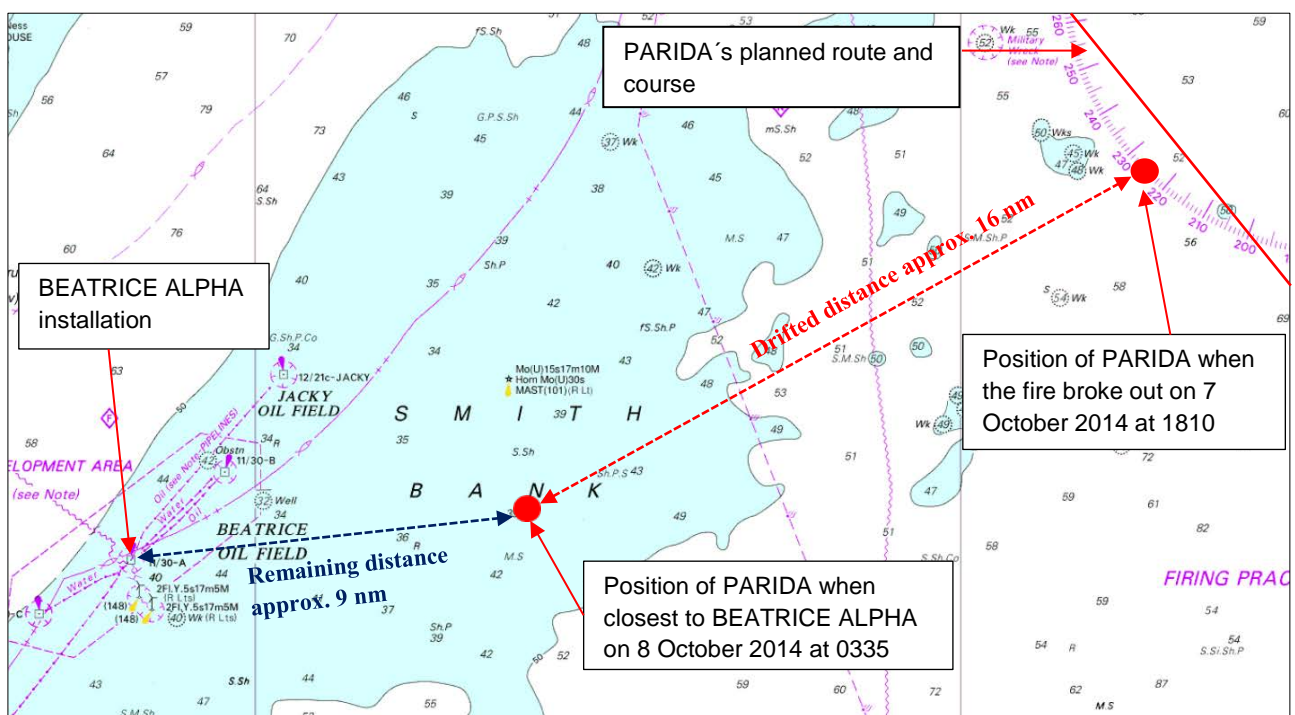
Figure 9: PARIDA's path during drifting

At 2225, the crew members on PARIDA had let out the starboard side anchor and chain fully with eight shackles on the sea bottom. The ship's distance to BEATRICE ALPHA was 13 nautical miles. Though the entire length of the starboard anchor chain was in the water, it had no effect. PARIDA continued drifting at a speed of 3-4 knots. The master therefore decided to let out the port side anchor. At 2310, the port side anchor and three shackles of anchor chain had been let out and the master observed that the drift was significantly reduced.

On 8 October 2014 at approx. 0400, PARIDA reached its closest proximity to BEATRICE ALPHA. The distance at that time was approx. 9 nautical miles (figure 9).

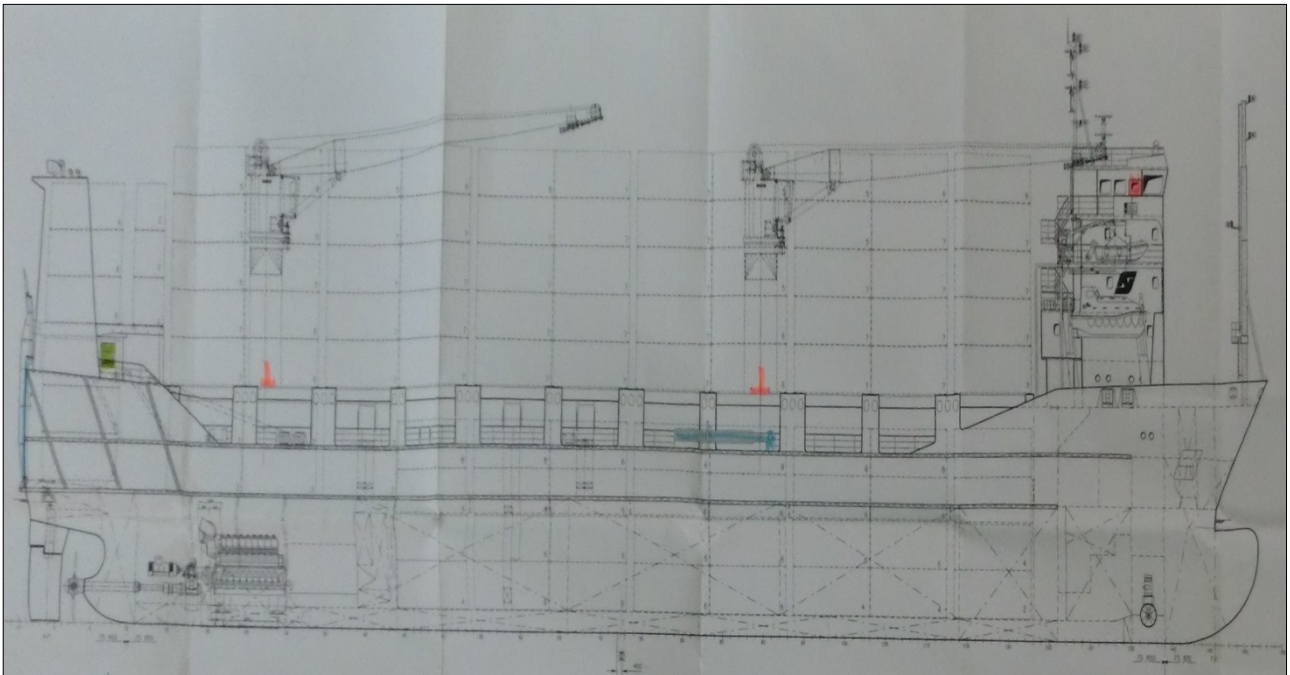
Figure 15: PARIDA general arrangement
Source: Harren & Partner

The accommodation was placed in the forward end of the ship and the engine room was located below the tween deck level in the ro-ro cargo space in the aft end of the ship. In between was the cargo space. The general layout is shown in figure 15.

PARIDA left Scrabster on the day of the accident with a draft of 4.6 m aft and 4.2 m forward. The design draft was 6.93 m. The relatively low draught on the day of the accident is likely to have made the aft part of the ship particularly susceptible to slamming from the sea during the prevailing weather conditions as the bottom of the aft ship would have been exposed in a way similar to what can be seen in figure 16. In the picture, the ship is shown alongside with approximately the same draught that it had on the day of the accident.

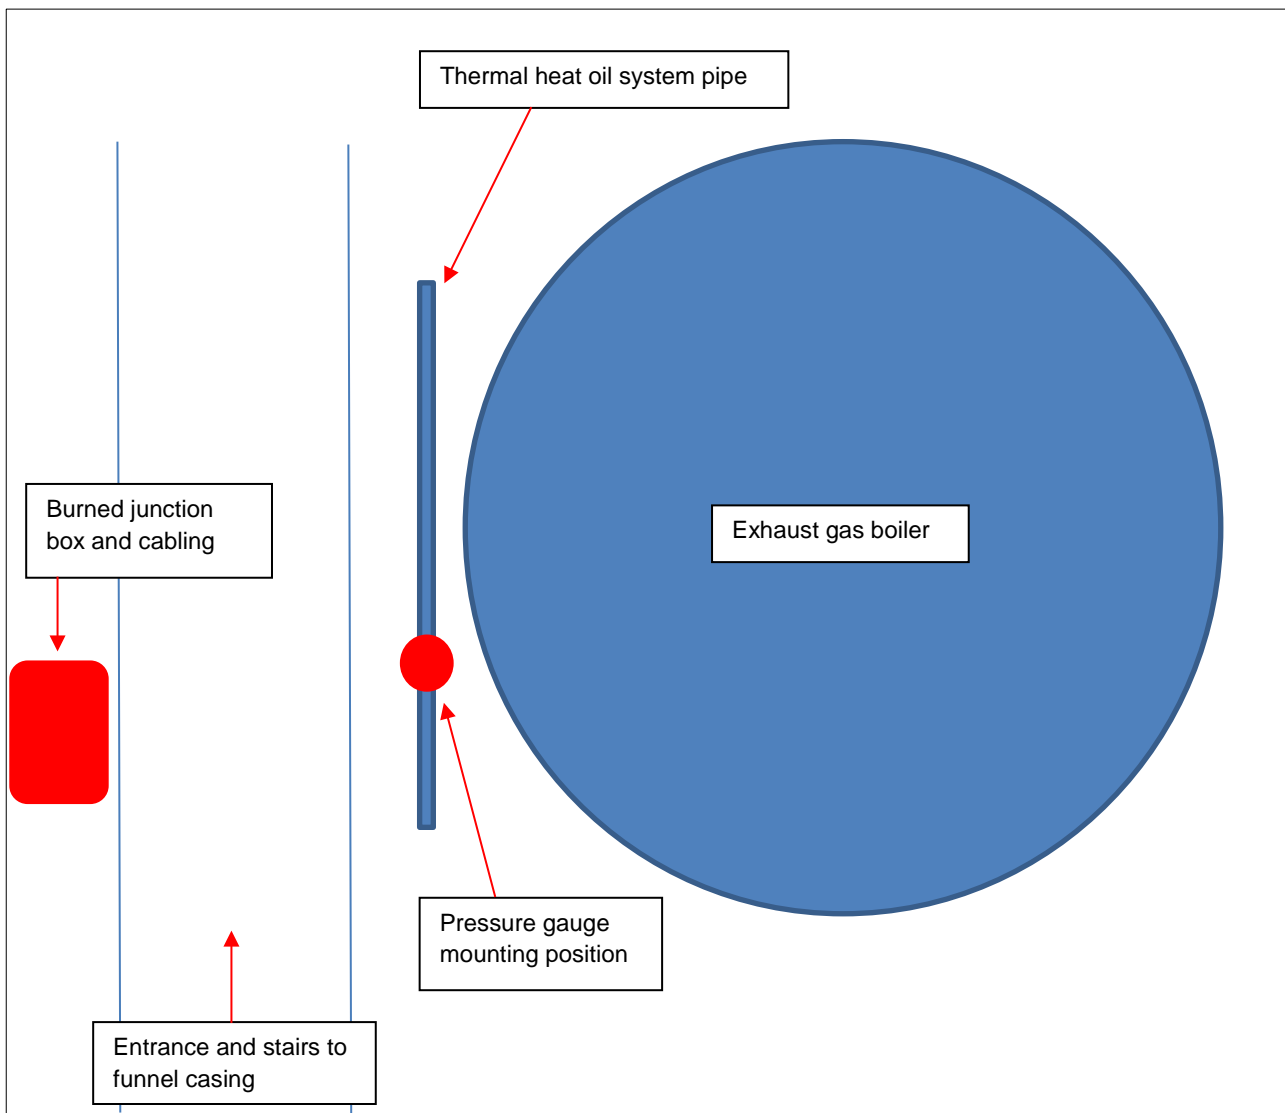
Figure 17: Funnel casing interior
Source: DMAIB

The funnel casing was located aft in the starboard side of the ship (figure 15). The space inside the funnel casing was entered through a door from the aft deck. Part of the ship's thermal heat-oil system equipment including the exhaust gas boiler was located inside the funnel casing space. A general layout of the components is seen in figure 17 below.

From the entrance, a stairway led to a lower level where access to the upper part of the exhaust gas boiler was gained. The pressure gauge that came off was fitted on the heat-oil inlet pipe to the exhaust gas boiler, also located on this level. Under the stairway, on the forward bulkhead, electrical wiring was connected in a mounted junction box.

From the lower level access to an auxiliary machinery room at the bottom of funnel casing, the hydraulic room, was gained.
